Congo River Crossing (CRX)
Pre-Commissioning Project

PPSA Seminar 16th November 2016, Aberdeen

Commissioning and Operational Pipeline Pigging

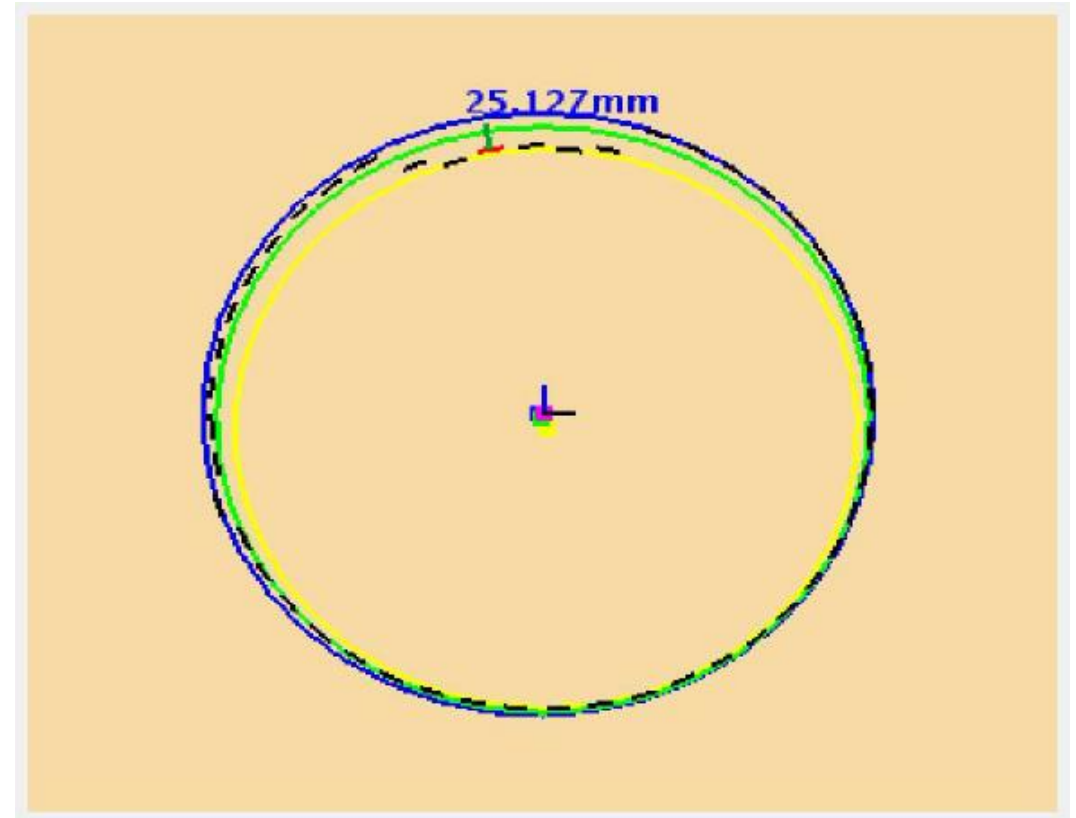
- Anomaly was discovered during the full analysis
- Feature showed a sharp profile indicating it was a foreign object rather than a dent
- After various discussions with Client and Company it was believed a welding shoe had attached itself to a girth weld

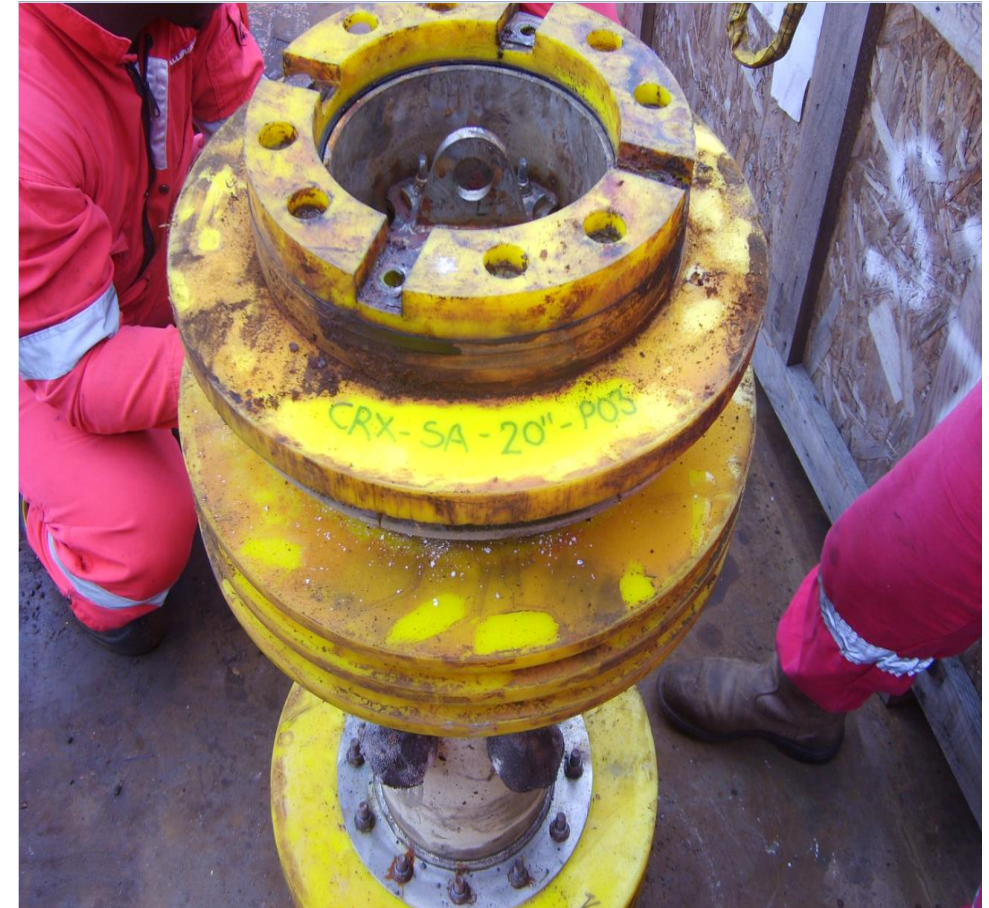
- Unexpected volume of debris in line when pigs recovered
- Required a fast mobilisation to perform additional cleaning runs completed by others

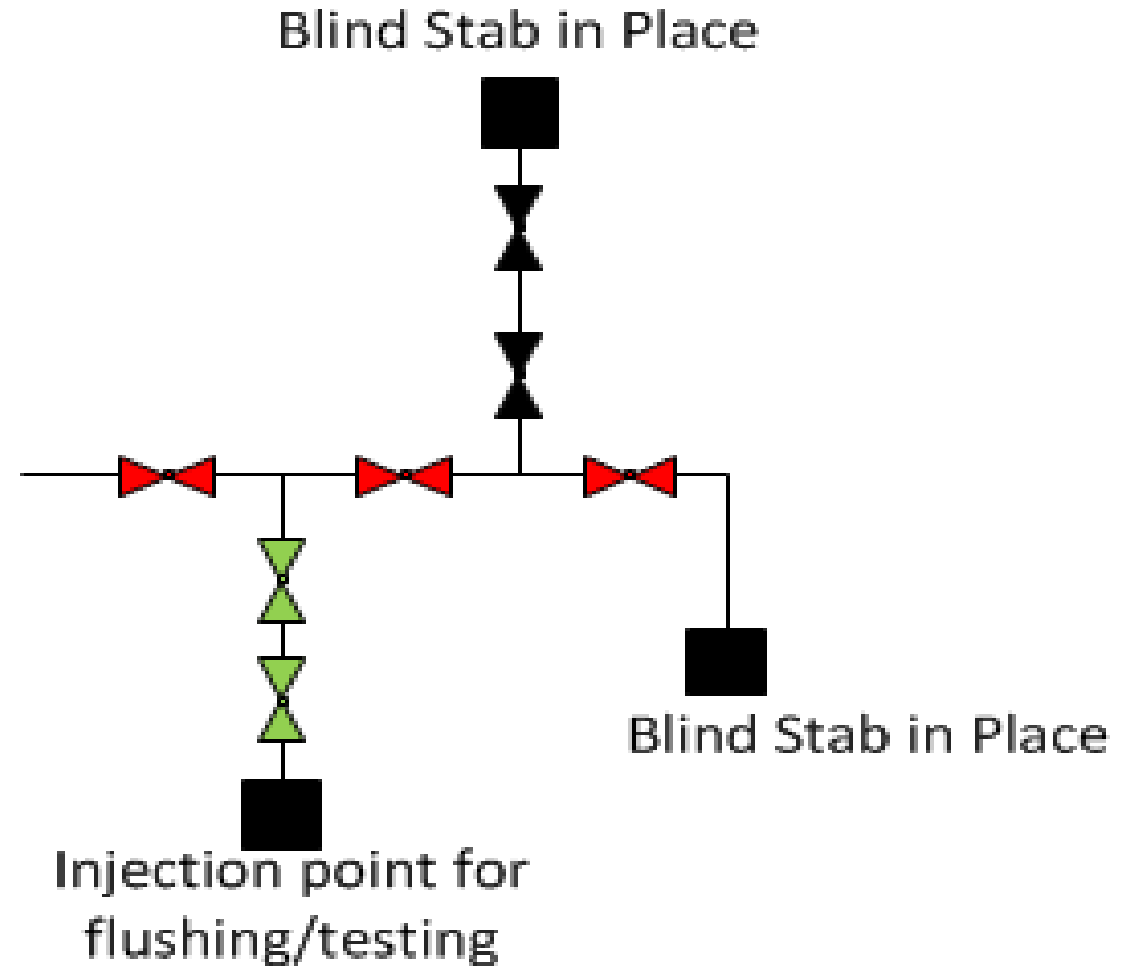
- Possible leaks through dummy hotstabs
- Initial operation required secondary vessel to complete valve operations
- A new campaign developed to flush and test each dead leg section
- On successful completion caliper run complete and line hydrotested
