PPSA Seminar 2022

Navigating difficult underwater installation - an I/I challenge

PIPELINE INFORMATION

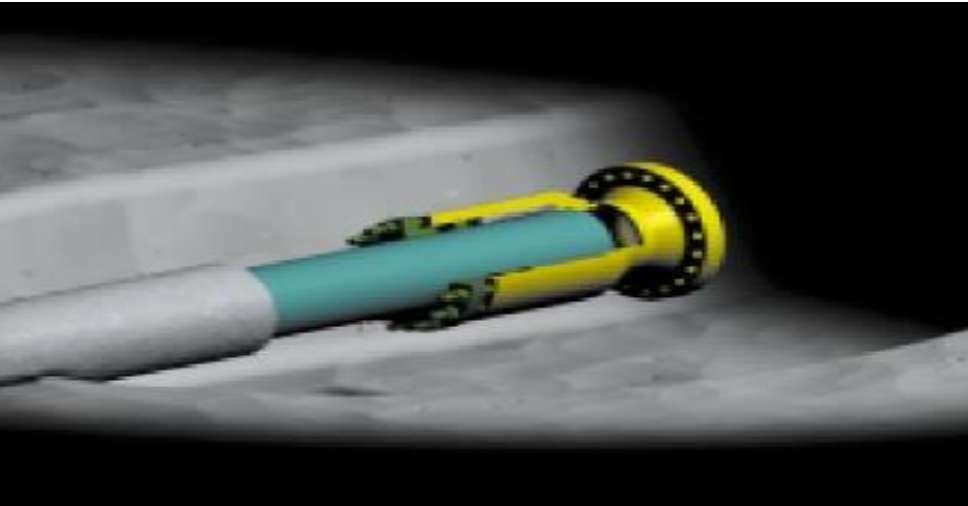
Pipeline End Connector (PEC)
“Hydrocouple”

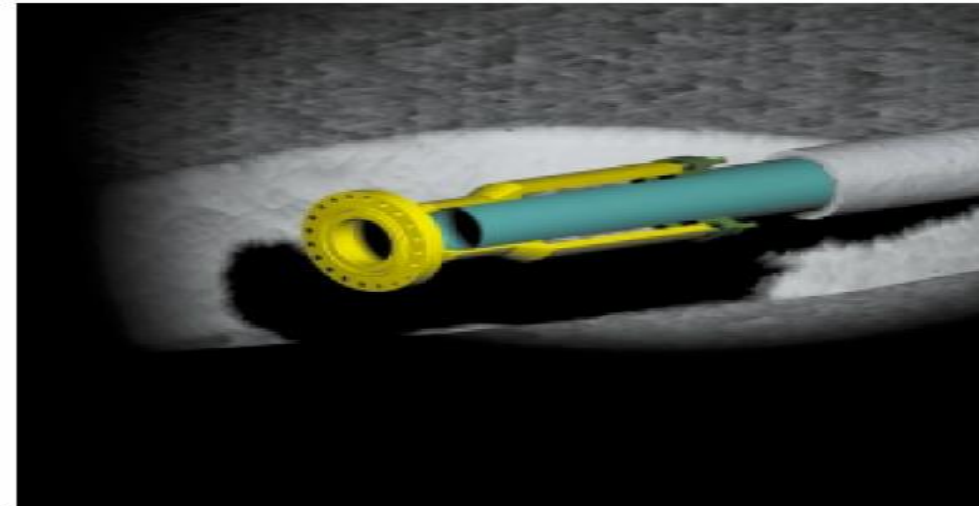
Pipeline End Connector (PEC)
“Hydrocouple”

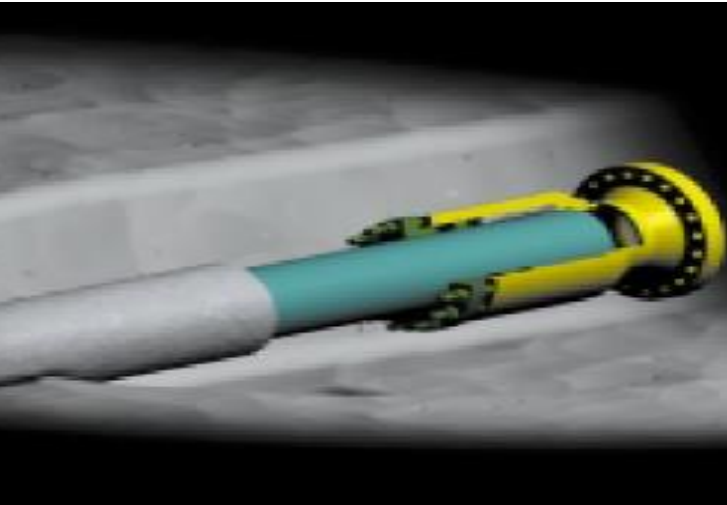
Pipeline End Connector (PEC)
“Hydrocouple”

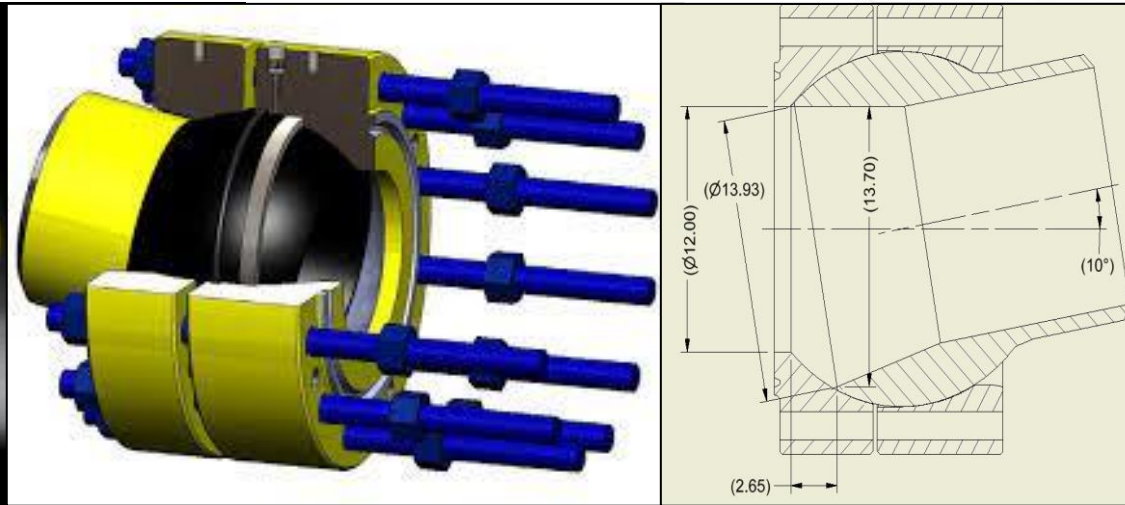
MisAligned Flange (MAF)

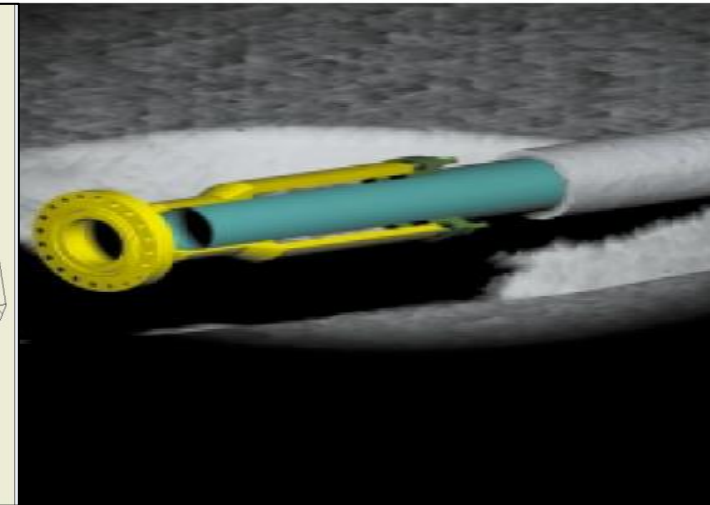
Pipeline End Connector (PEC)
“Hydrocouple”

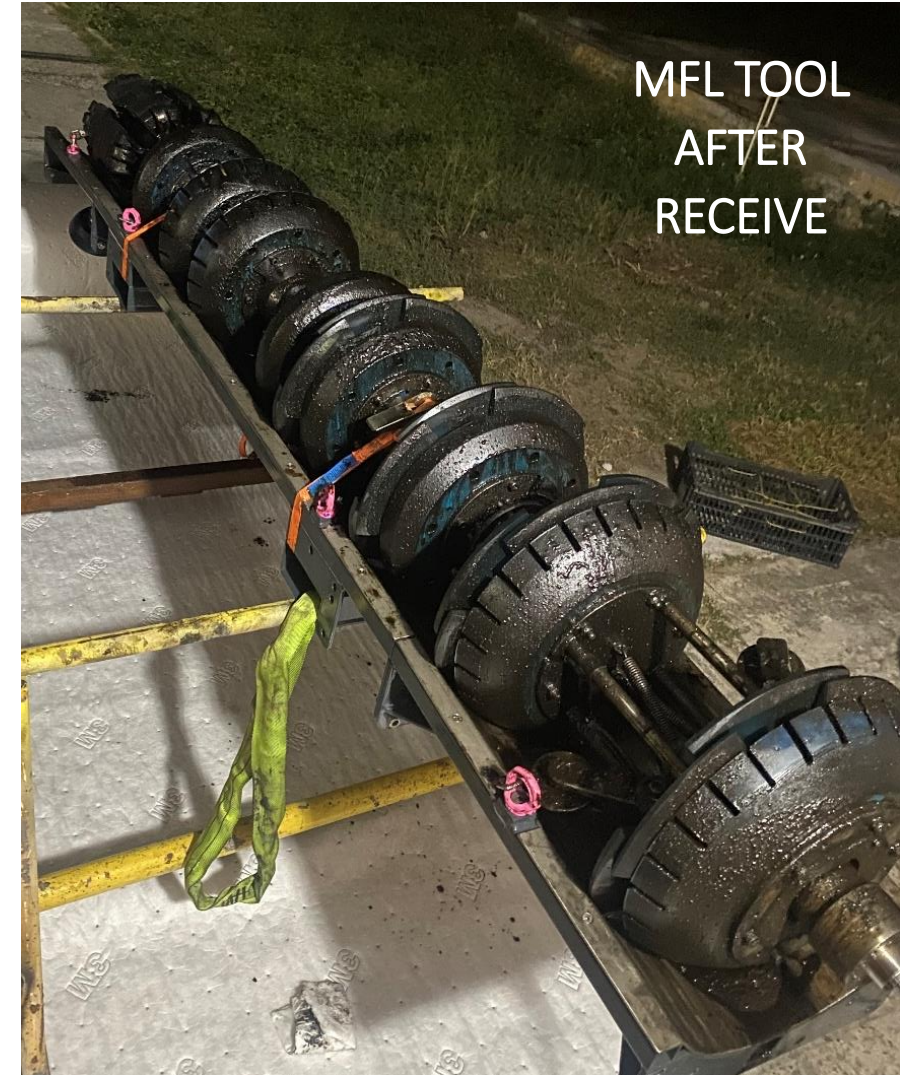
MFL TOOL
AFTER
RECEIVE

TOOL RECEIVED IN GOOD
CONDITION AND COMPLETE
DATA SET – SUCCESSFUL ILI RUN

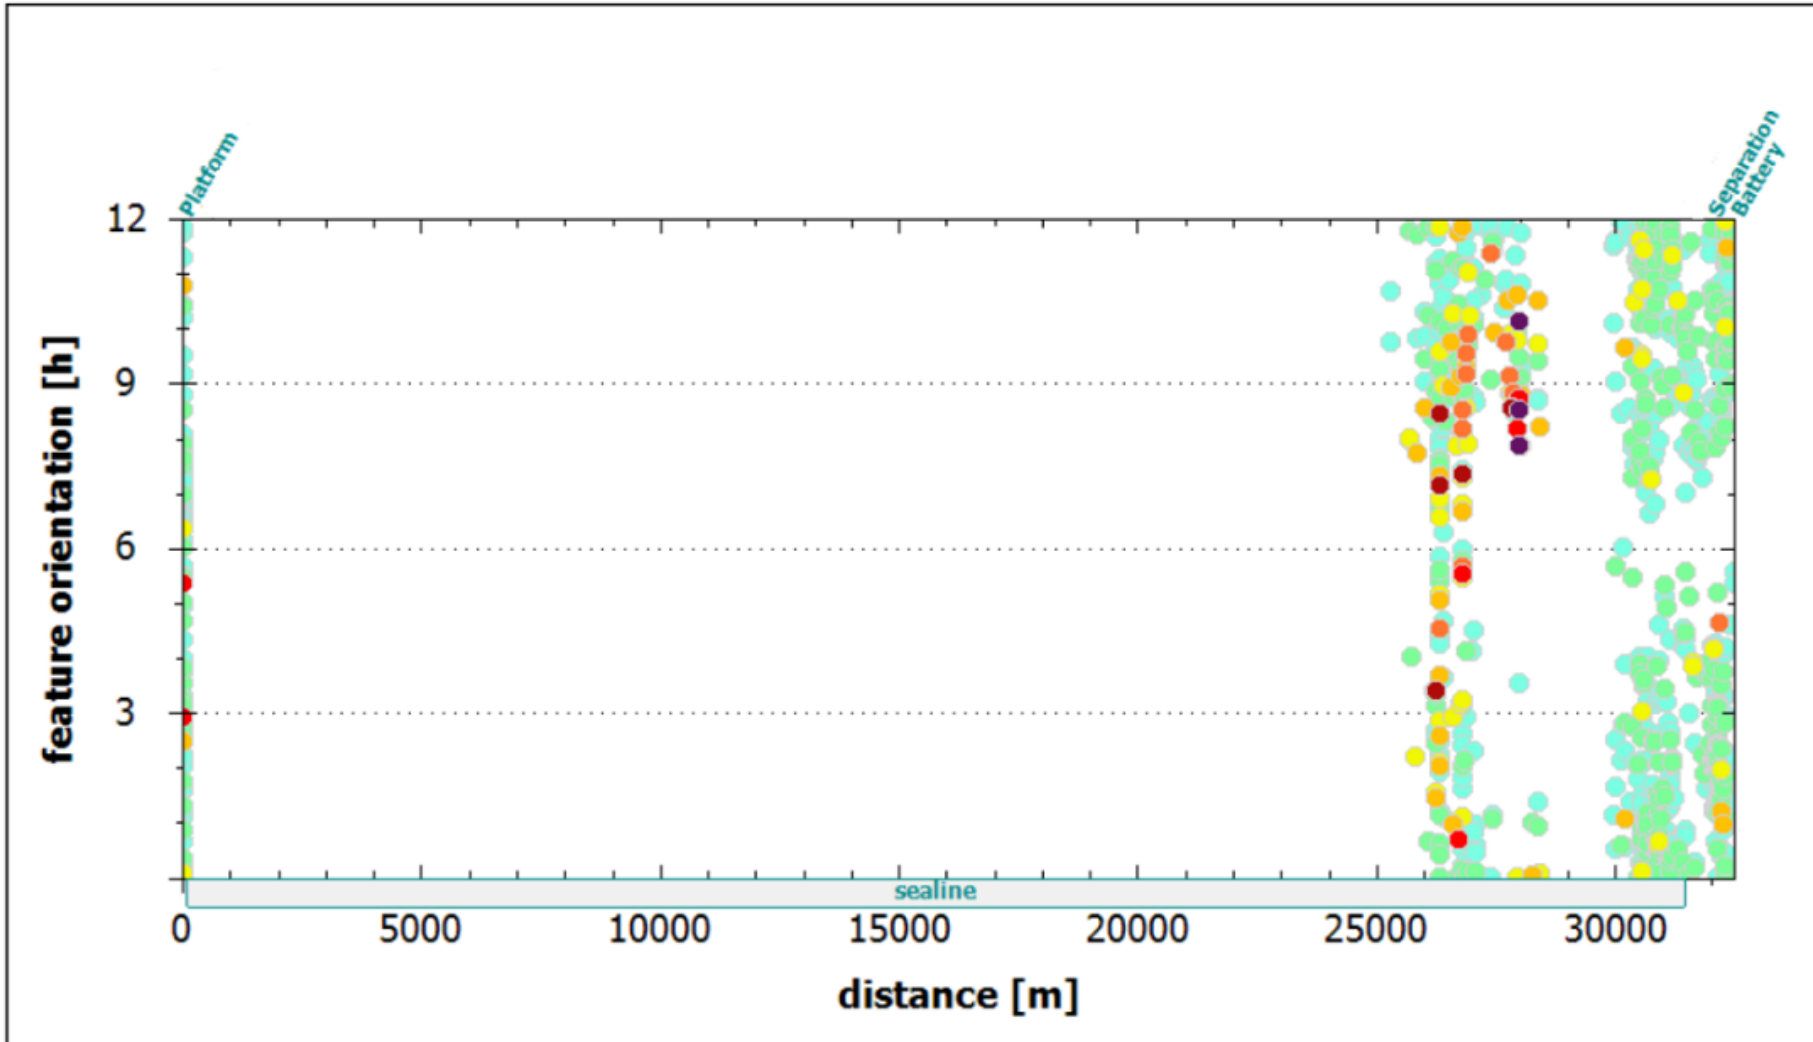
Distribution of external metal loss over the pipeline length and circumference

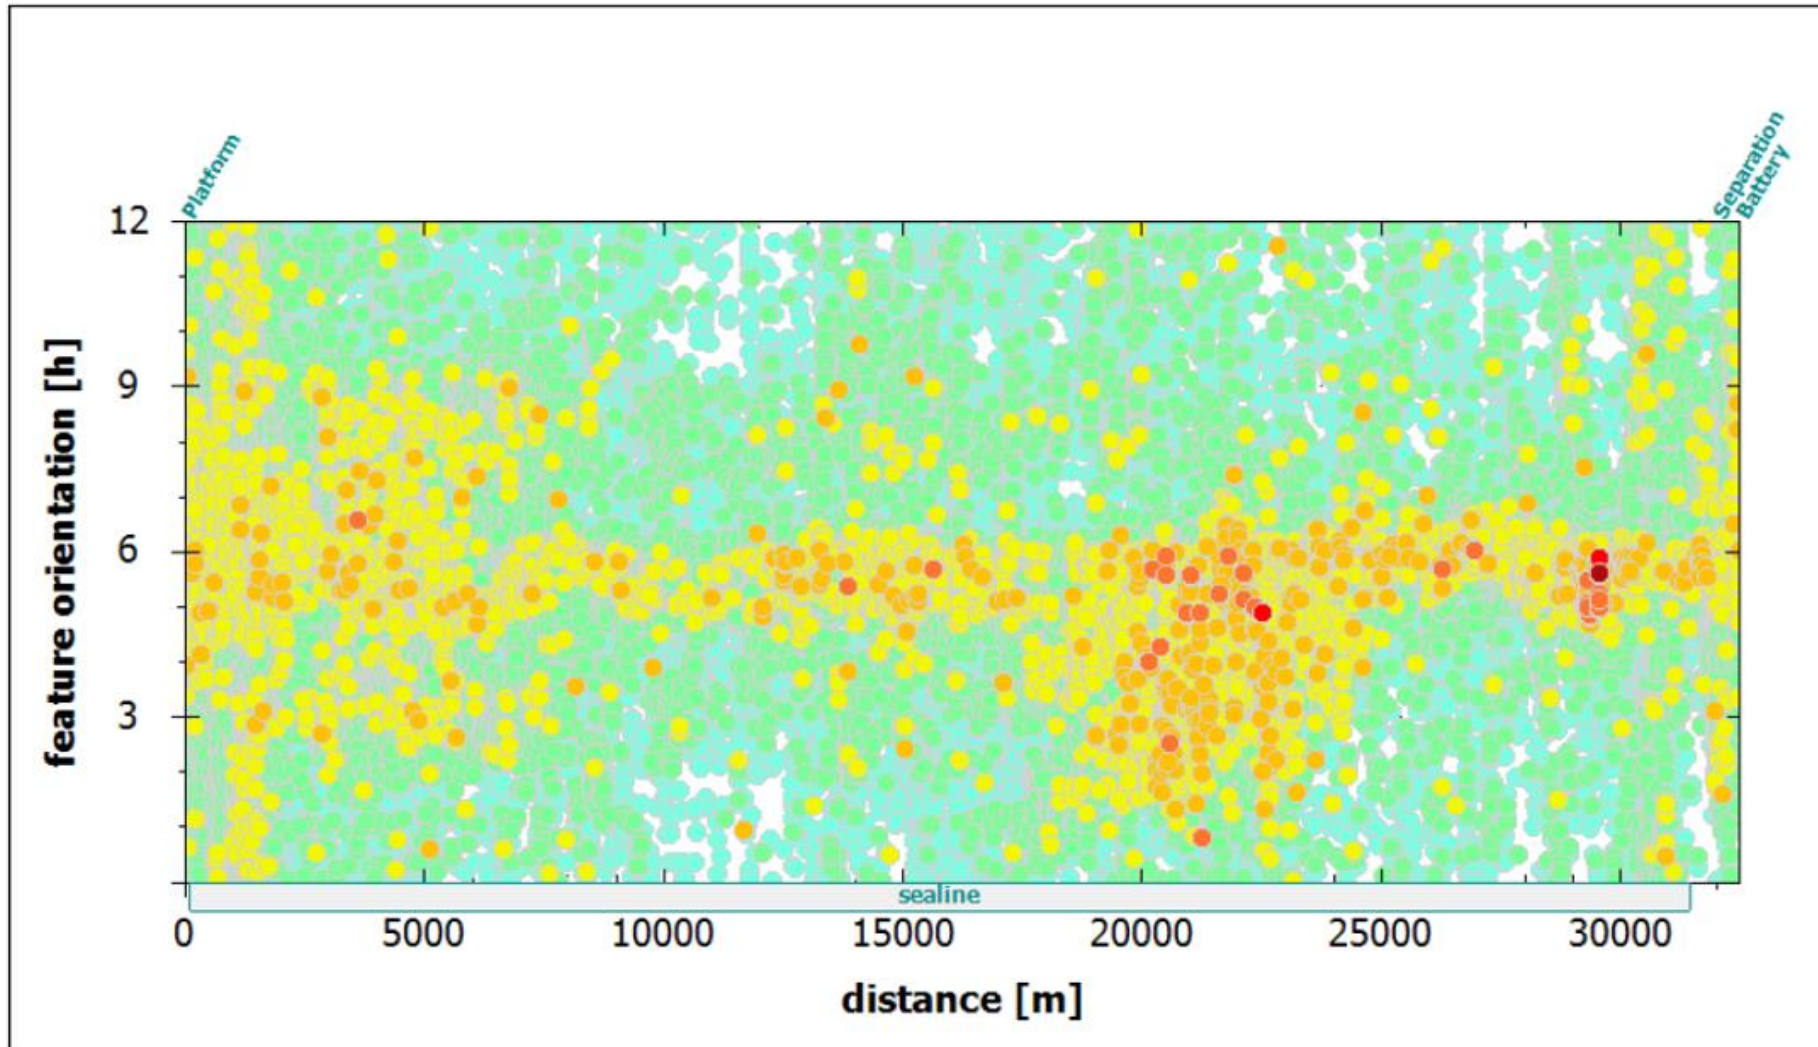
Distribution of internal metal loss over the pipeline length and circumference
