InVista™ Inspection & LifeQuest™ Assessment

Integrated Solution Set Addressing Unpiggable and Difficult Pipelines

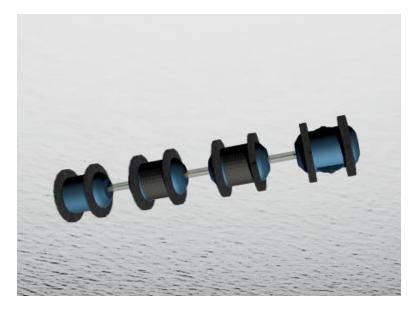
InVista™ Ultrasonic Inline Inspection

- High-fidelity ultrasonic inline inspection of unpiggable and difficult pipelines 3" (75mm) – 14" (355mm) in diameter
- Combined absolute wall loss and full geometry dimensions in a single pass
- Circumferential, longitudinal and ID/OD location of defects with referencing
- High-density direct measurement ultrasonic technology provides accurate, repeatable results measured to 0.005" (0.127mm) precision & 0.030" (0.762mm) remaining wall

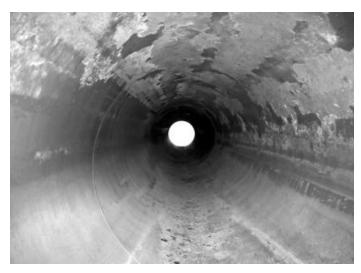
InVista™ High-Fidelity Approach

- The term "high-fidelity" refers to the reproduction of sound and images with minimal distortion. Less distortion means superior, more accurate data.
- Signal distortion and other noise effects can reduce the ILI tool's ability to fully discriminate and properly size pipeline flaws, thereby exposing you to increased risk.
- By design, InVista™ is not subject to the same noise effects associated with movement, pipeline disturbances and related wear challenges as conventional tools.
- Our advanced approach produces the highest quality images available in the industry today.

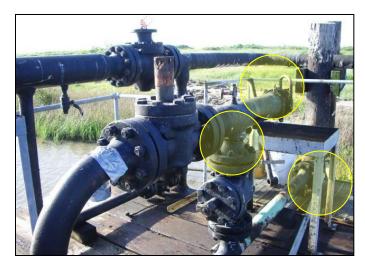
InVista™ is Successful

Launcher

- Minimal working area
- · Minimal trap length
- Unbarred 6" x 6" (150mm)
 tee at 6 o'clock

Receiver

- Minimal nominal pipe after valve
- Minimal trap length
- Line was not properly cleaned prior to ILI

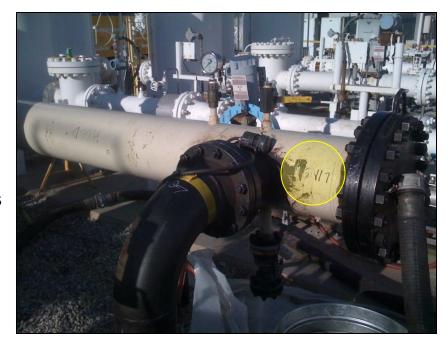
InVista™ is Successful

Pipeline Details

- •Same location for both launch and receive using client-owned 14" barrel.
- •Multi-diameter pipeline was easily inspected using two tools at client's request:
 - 1. Ran 8" (200mm) tool to 6" (150mm) reducer and back out.
 - 2. Ran 6" tool through 8" line, through 6" and back out.
- •Inspected over 1 mile of pipe below city streets with limited access.
- •No prior inspection due to tight bends, unbarred tee and plug valves
- Legacy line—no original drawings

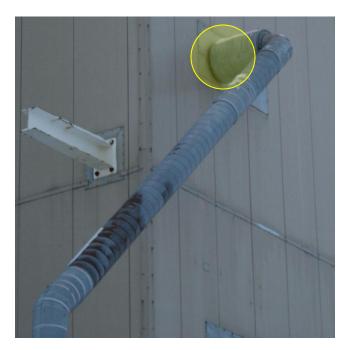
InVista™ is Successful

Pipeline Details

- •Two 6" (150mm) produced water pipelines tied together for approximately 7 miles
- •Pipeline pressure 1500 PSI (103.4bar) and 150 degrees
- •No prior inspection due to limited trap lengths--No modifications required for InVista
- •Launcher reduced from 12" (305mm) to 10" (250mm) to 8" (200mm) then to 6" (150mm) nominal in one instance
- •Insulated pipe could normally be inspected with manual UT, but this was >100 ft (33M) from the ground.
