IN-LINE INSPECTION OF PIPES USING CORROSION RESISTANT ALLOYS (CRA)

M.Sc. Johannes Keuter
PPSA Seminar · Aberdeen · 19-Nov-2014

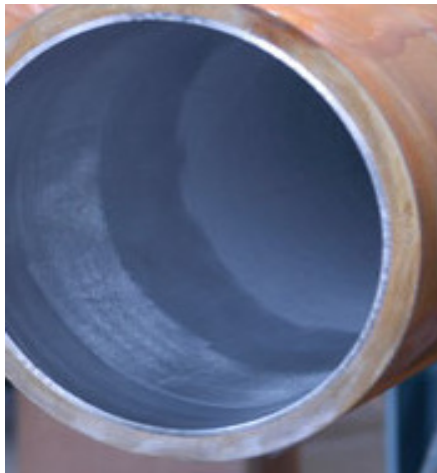
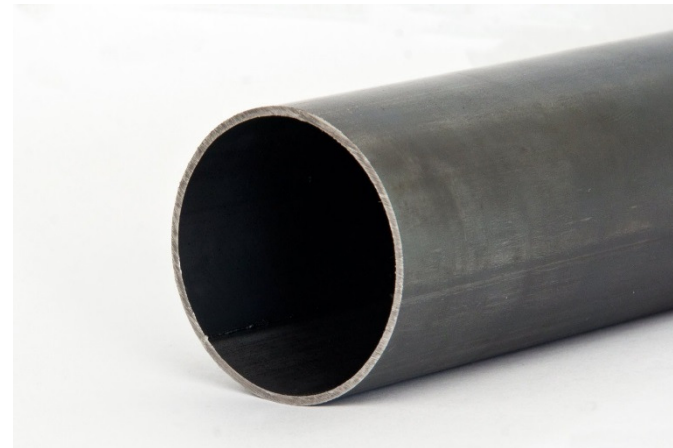
These pipeline types are considered: Pipelines with internal metal layer

Lined CRA
pipes

Cladded
CRA pipes

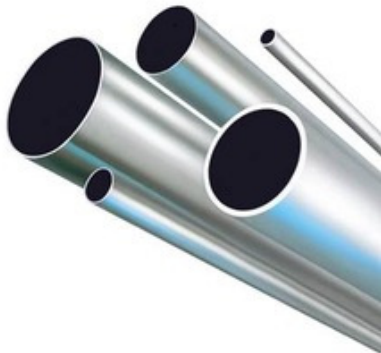
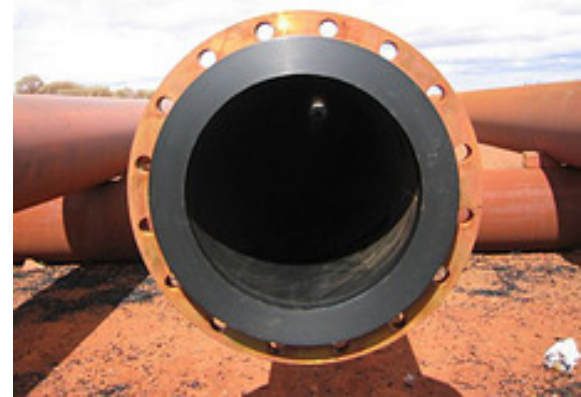
These pipeline types are not considered:

Duplex

HDPE Layer

Hyper-Duplex

Martensitic steel

High chromium 13CrMSS

Super-Duplex

PU Layer

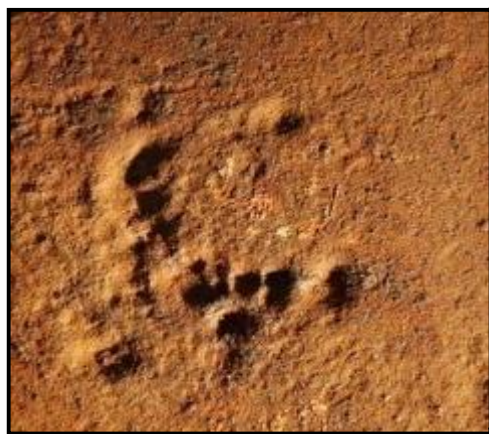
Top of Line Corrosion (TLC)

Localized, small-scale corrosion

Dissolution of aggressive gases in droplets support corrosion

TLC can reveal high growth rates, up to several mm/year

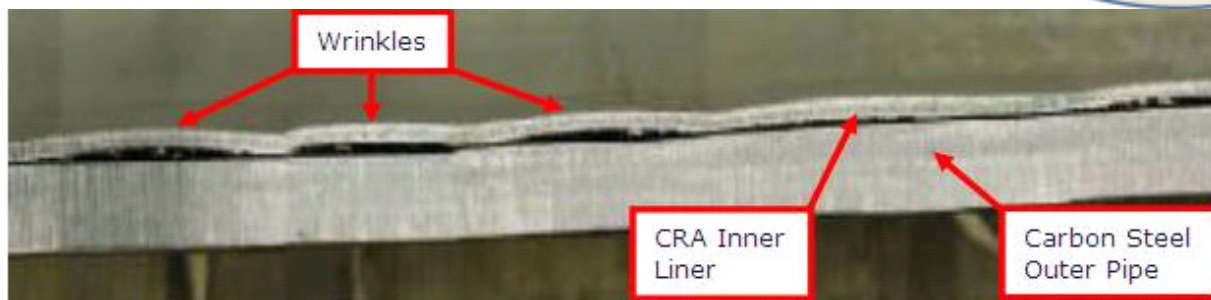
Expected defects in CRA pipe

- External defects in carbon steel (CS), e.g. corrosion
- Internal defects between carbon steel and stainless steel
- Erosion in CRA due to e.g. sand
- Pitting in the CRA e.g. caused by seawater ingress or galvanic corrosion
- Geometric deformations in CRA (e.g. wrinkles, dents)

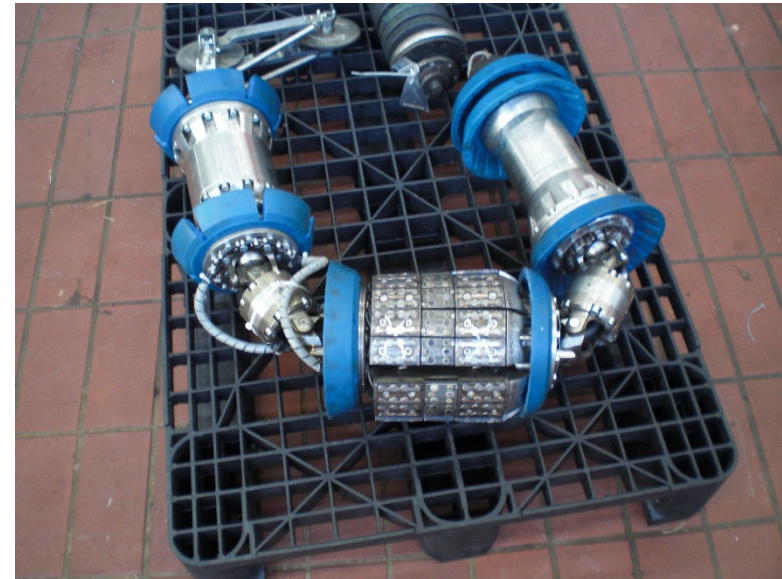
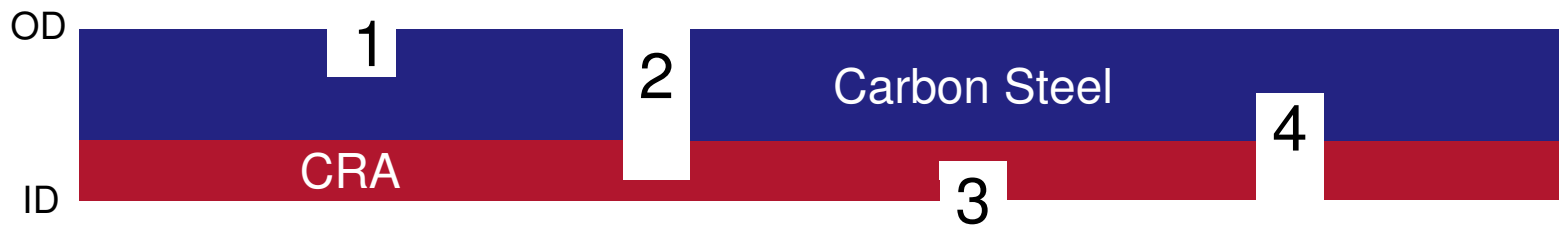
Pull-Test setup at RTRC:

08" spool (clad)

10mm WT CS

3.9mm WT CRA (Alloy 825)

Types of features:

External
Feature in CS

External Feature
in CS & CRA

Internal Feature
in CRA

Internal Feature
in CRA & CS

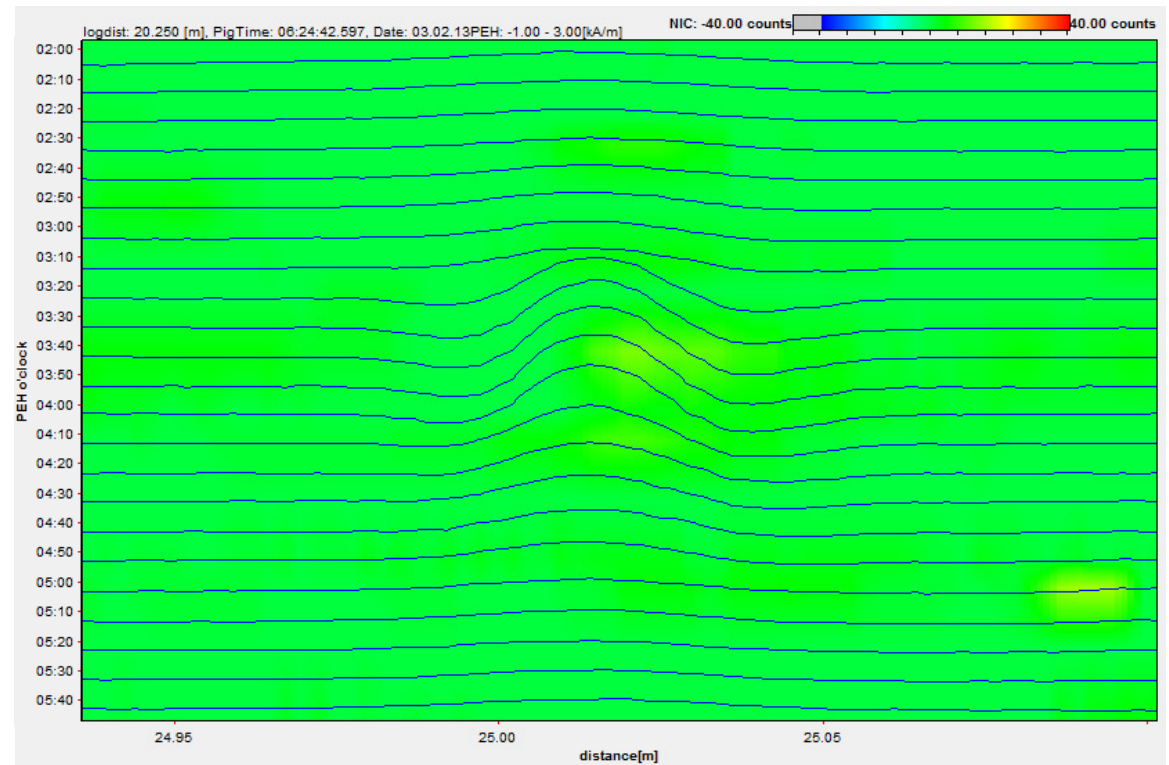
6.5mm external defect in steel

- Axial MFL channel (lines): clear signal, sizable as 65% in steel
- Internal detection sensor on MFL tool (colors): no signal

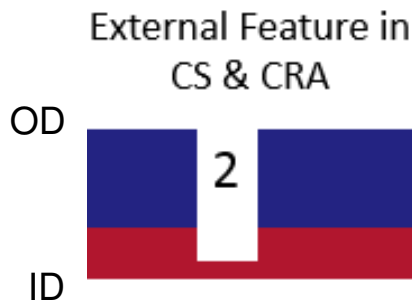
13mm external defect through steel into cladding

- Axial MFL channel (lines): clear signal, sizable as 100% in steel
- Internal detection sensor on MFL tool (colors): no signal

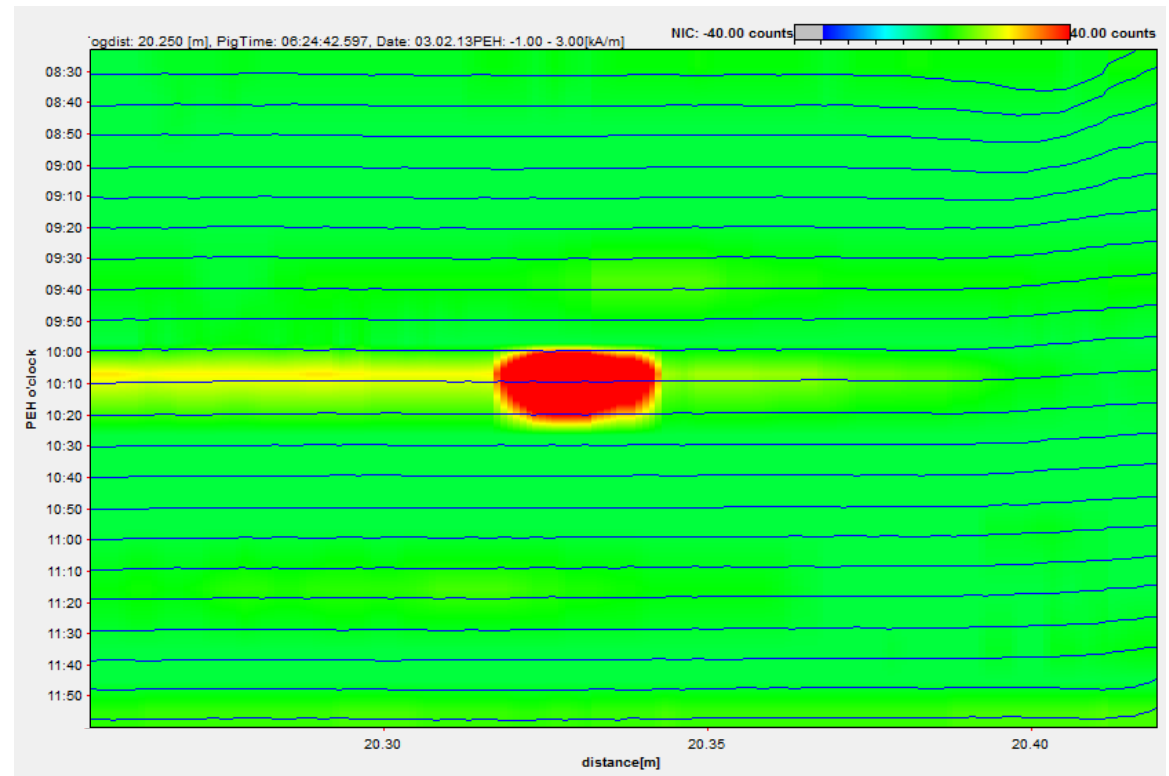
3mm Internal defect in cladding

- Axial MFL channel (lines): no signal
- Internal detection sensor on MFL tool (colors): clear detection

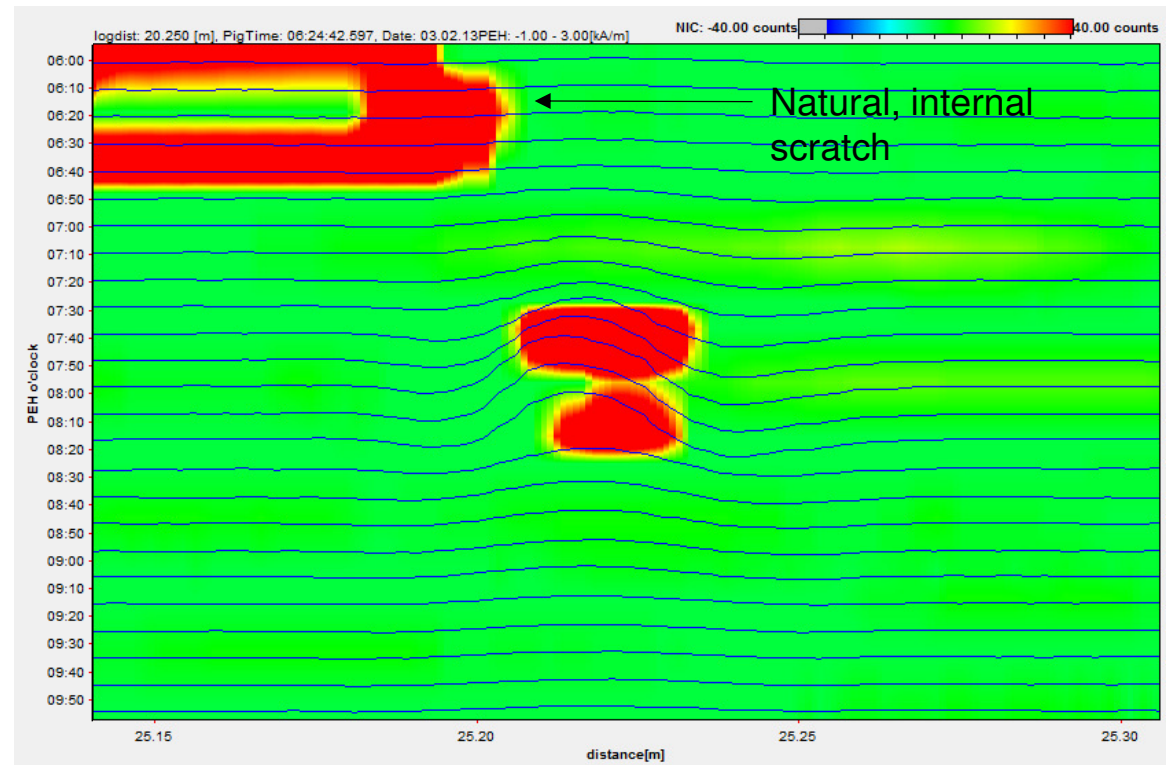
Internal defect through cladding and 7mm into the steel

- Axial MFL channel (lines): clear signal; sizable as 70% in steel
- Internal detection sensor on MFL tool (colors): clear detection

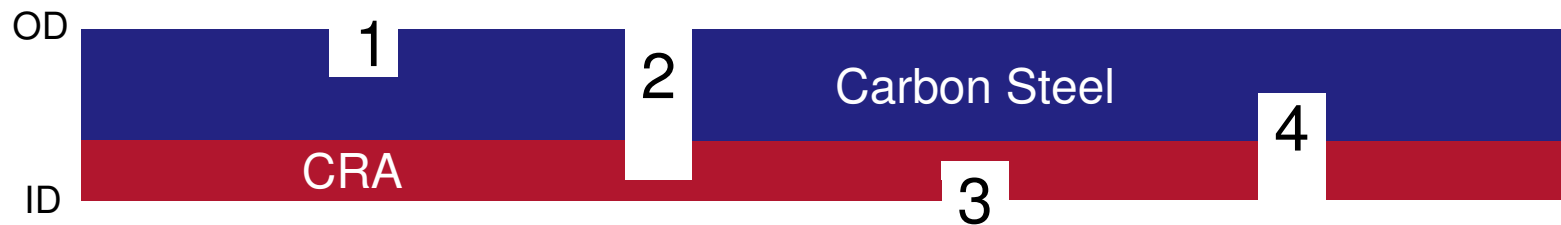
Pull-Test setup at RTRC:

08" spool (clad)

10mm WT CS

3.9mm WT CRA (Alloy 825)

Types of features:

External Feature in CS

External Feature in CS & CRA

Internal Feature in CRA

Internal Feature in CRA & CS

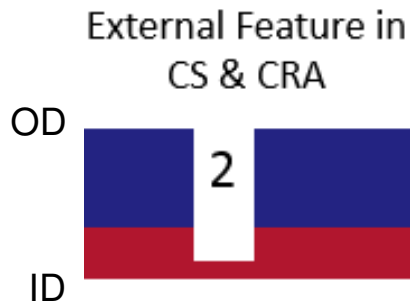
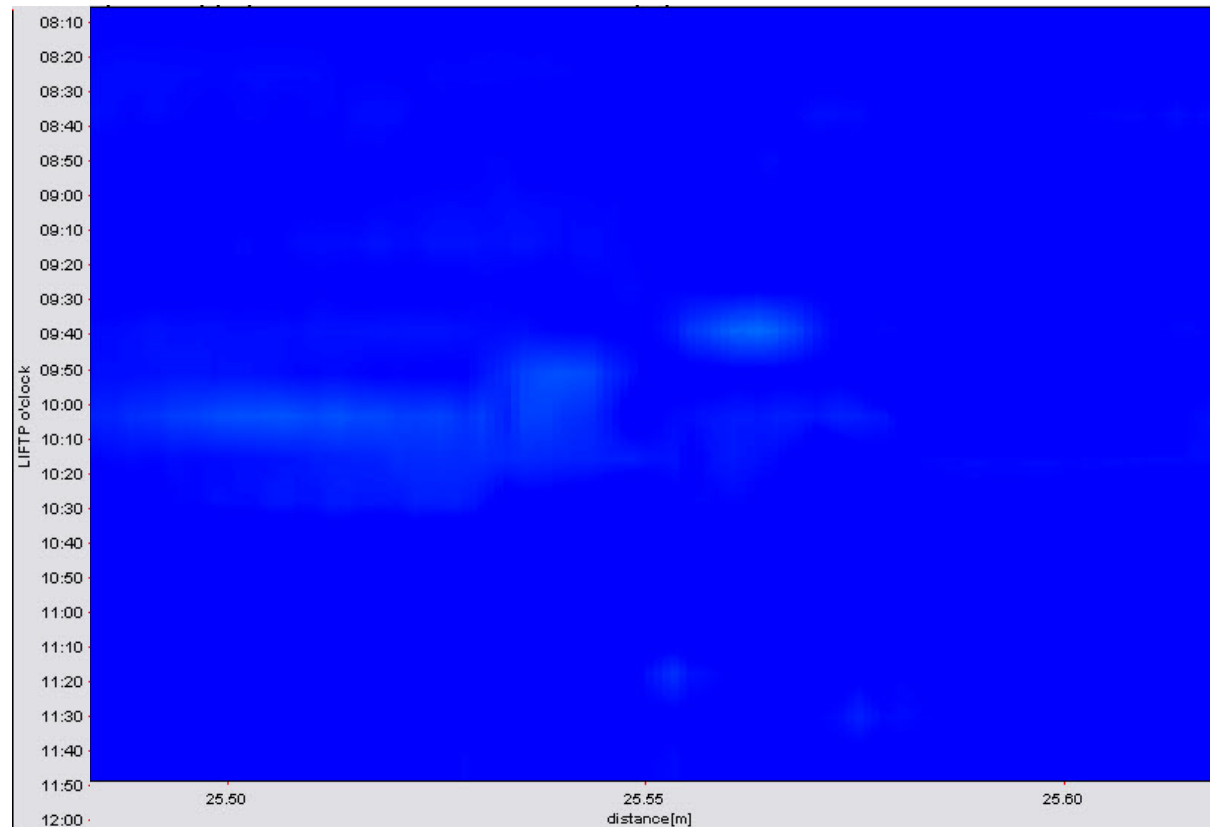
13mm external defect through steel into cladding

- Internal detection sensor on IEC tool (colors): no signal

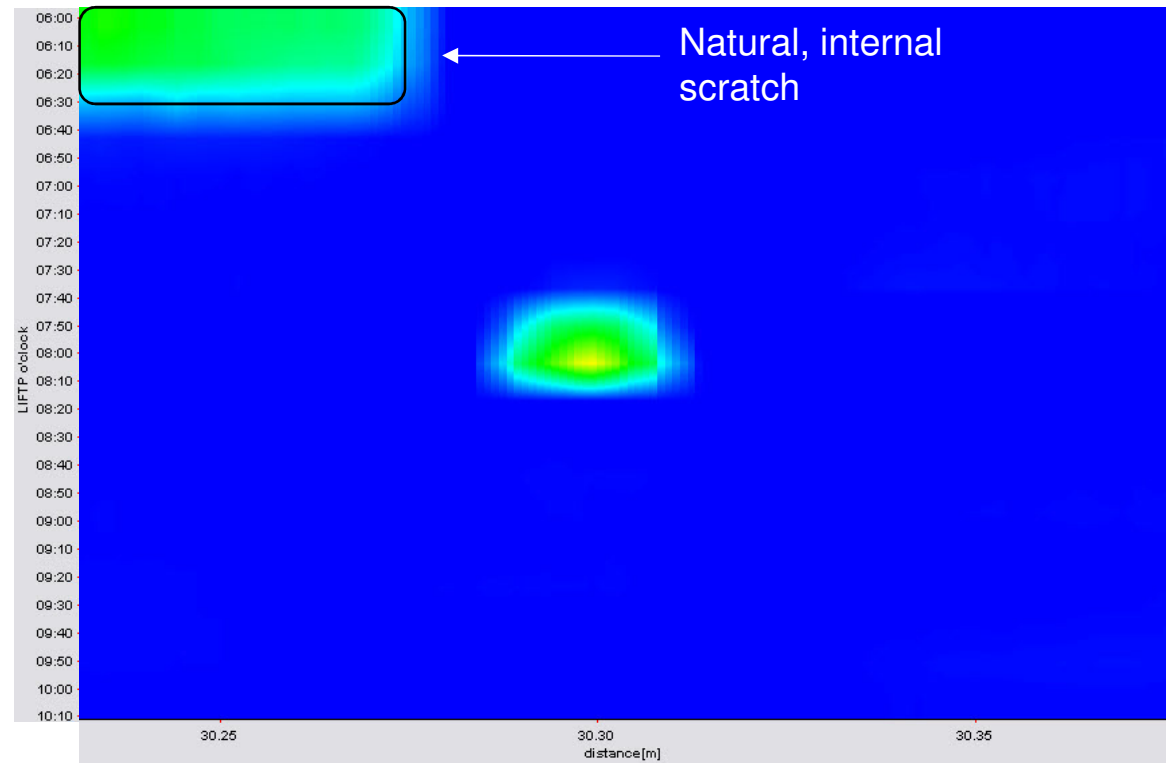
Internal defect through cladding and 7mm into the steel

- Internal detection sensor on IEC tool (colors): clear detection

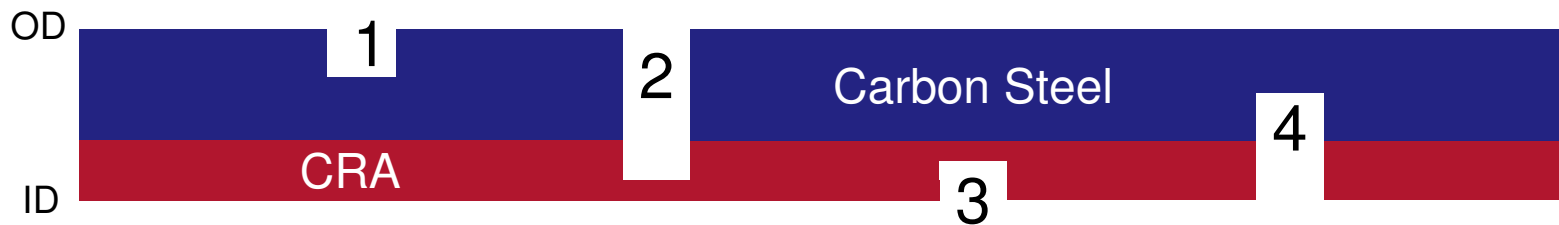
Pump-Test setup at RTRC:

08" spool (clad)

10mm WT CS

3.9mm WT CRA (Alloy 825)

Types of features:

External
Feature in CS

External Feature
in CS & CRA

Internal Feature
in CRA

Internal Feature
in CRA & CS

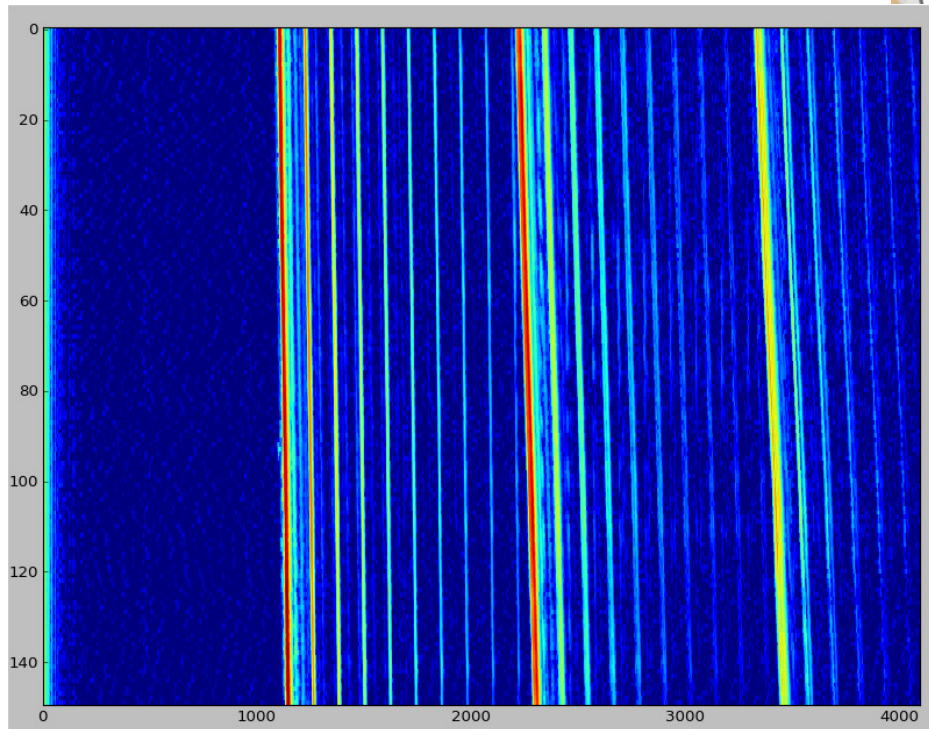
Laboratory test at RTRC:

- 16" spool (clad)
- 12.5mm WT CS
- 3.0mm WT CRA (316L)

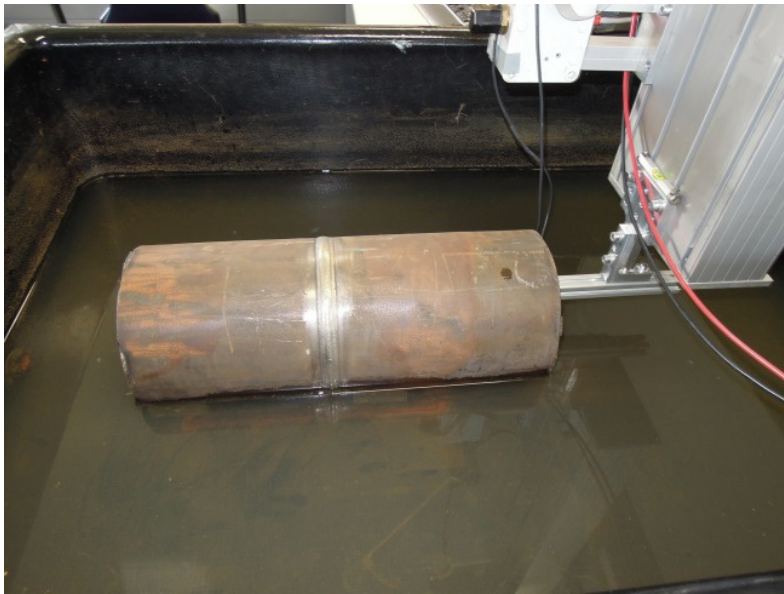
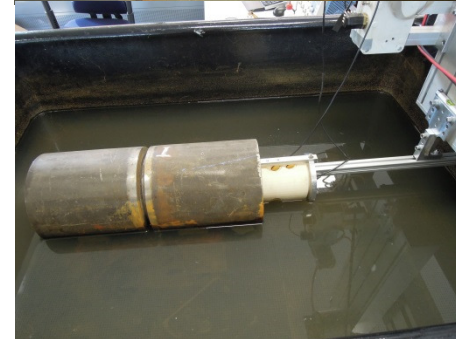
Laboratory test at RTRC:

- 06” spool (lined)
- 15.9mm WT CS
- 5.0mm WT CRA (Alloy 825)
