THE *Apache* INTELLIGENT PIGGING PROJECT

Ed Bartlett, Apache & Tom Steinvorte, ROSEN · PPSA Aberdeen · 07-11-2018

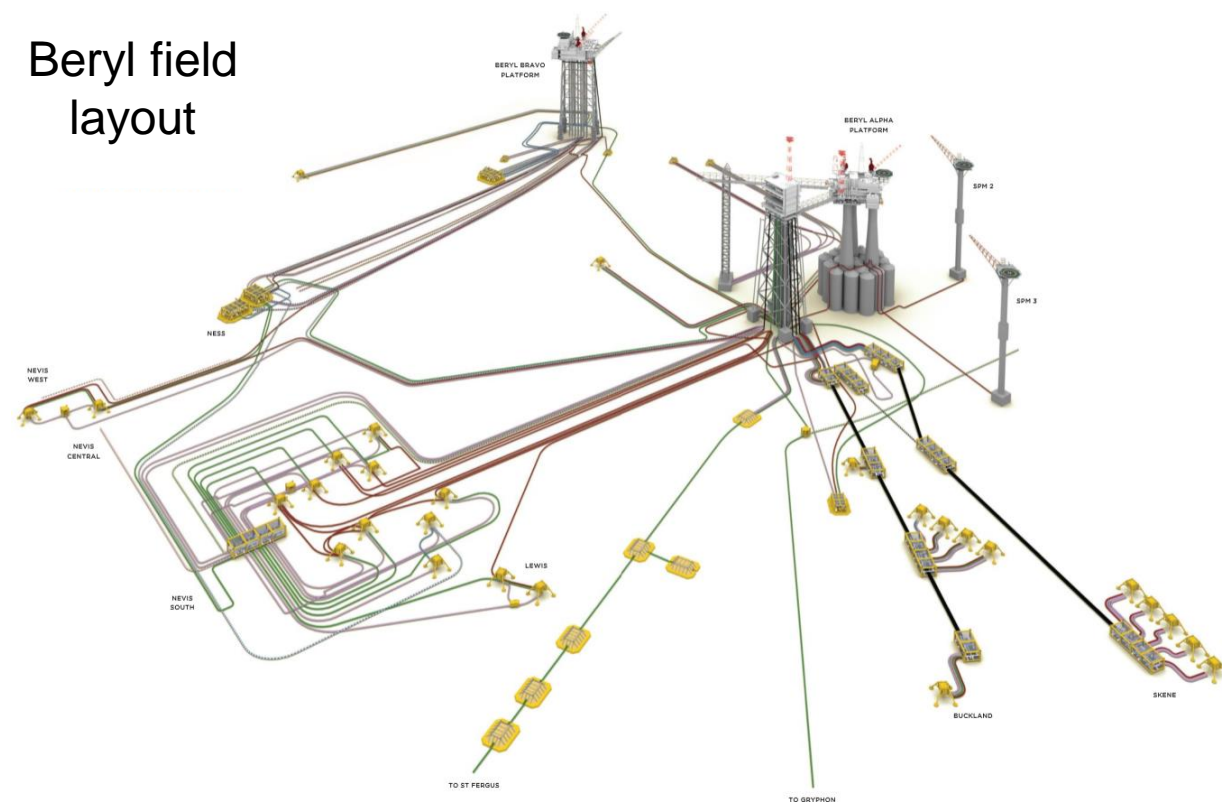
Beryl field layout

Beryl B – Beryl A Offshore Oil line with Wax (PL120) 18/20" x 8.4km	
Diameter	18/20" 20" Line transitions down to 18" at Beryl A riser
ID variation	385mm (measured in 1.5D bend) Beryl A riser 489mm max in Beryl B launcher & riser 473mm is nominal ID Step change between 466m and 489mm
MBR	20" Beryl A riser has 1.5 D bends. Back to back 1.5D in the 408mm (20" 50mm wt Beryl A riser) 3D bends in the 419mm (18" 19mm wt Beryl B riser) Miter bend at Bravo riser (design not available)
Line Length	8.4 km (@0.12 m/s ~ 20 hours run time)
Wall Thicknesses	20" mainline – 17.5mm 20" Beryl B Riser – 9.5mm / 12.5mm / 19.05 mm / 21 mm 20" Beryl A Riser – 50mm 18" Beryl A riser – 19mm
Water Depth	~ 120m

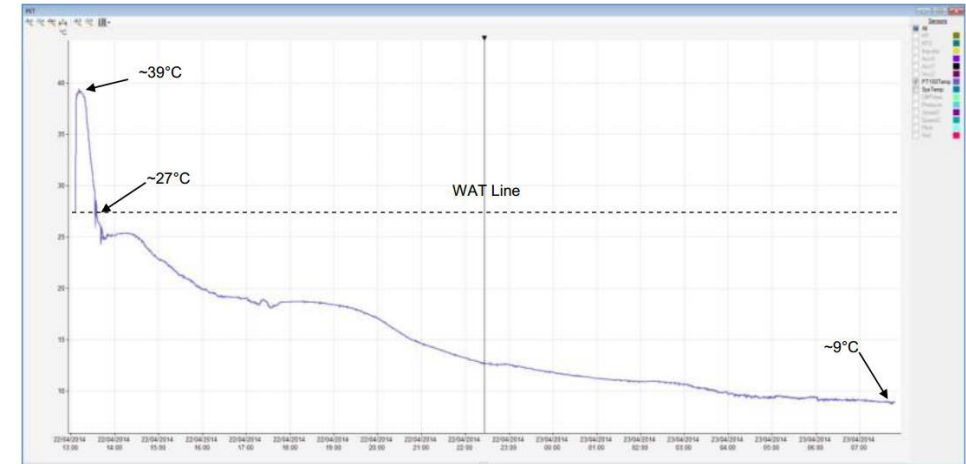
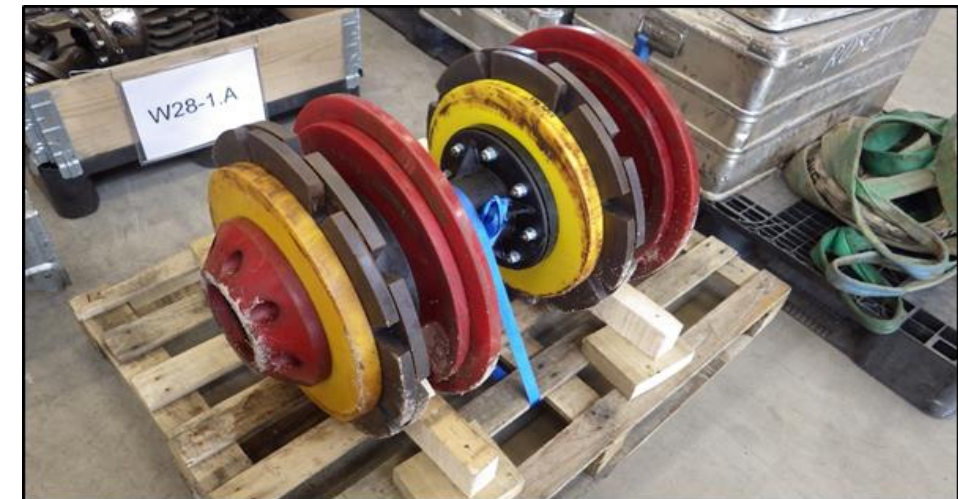
Temperature Profile °C

- Weekly metal bodied pig run through line
- 300-600 kg estimated wax returns
- Currently difficult to assess because of Benzene
- Debris Mapping used to track progress
- Low flow and pressure may result in bypass around tool critical in 1.5D bend features.
- MAOP is 13.1 bar

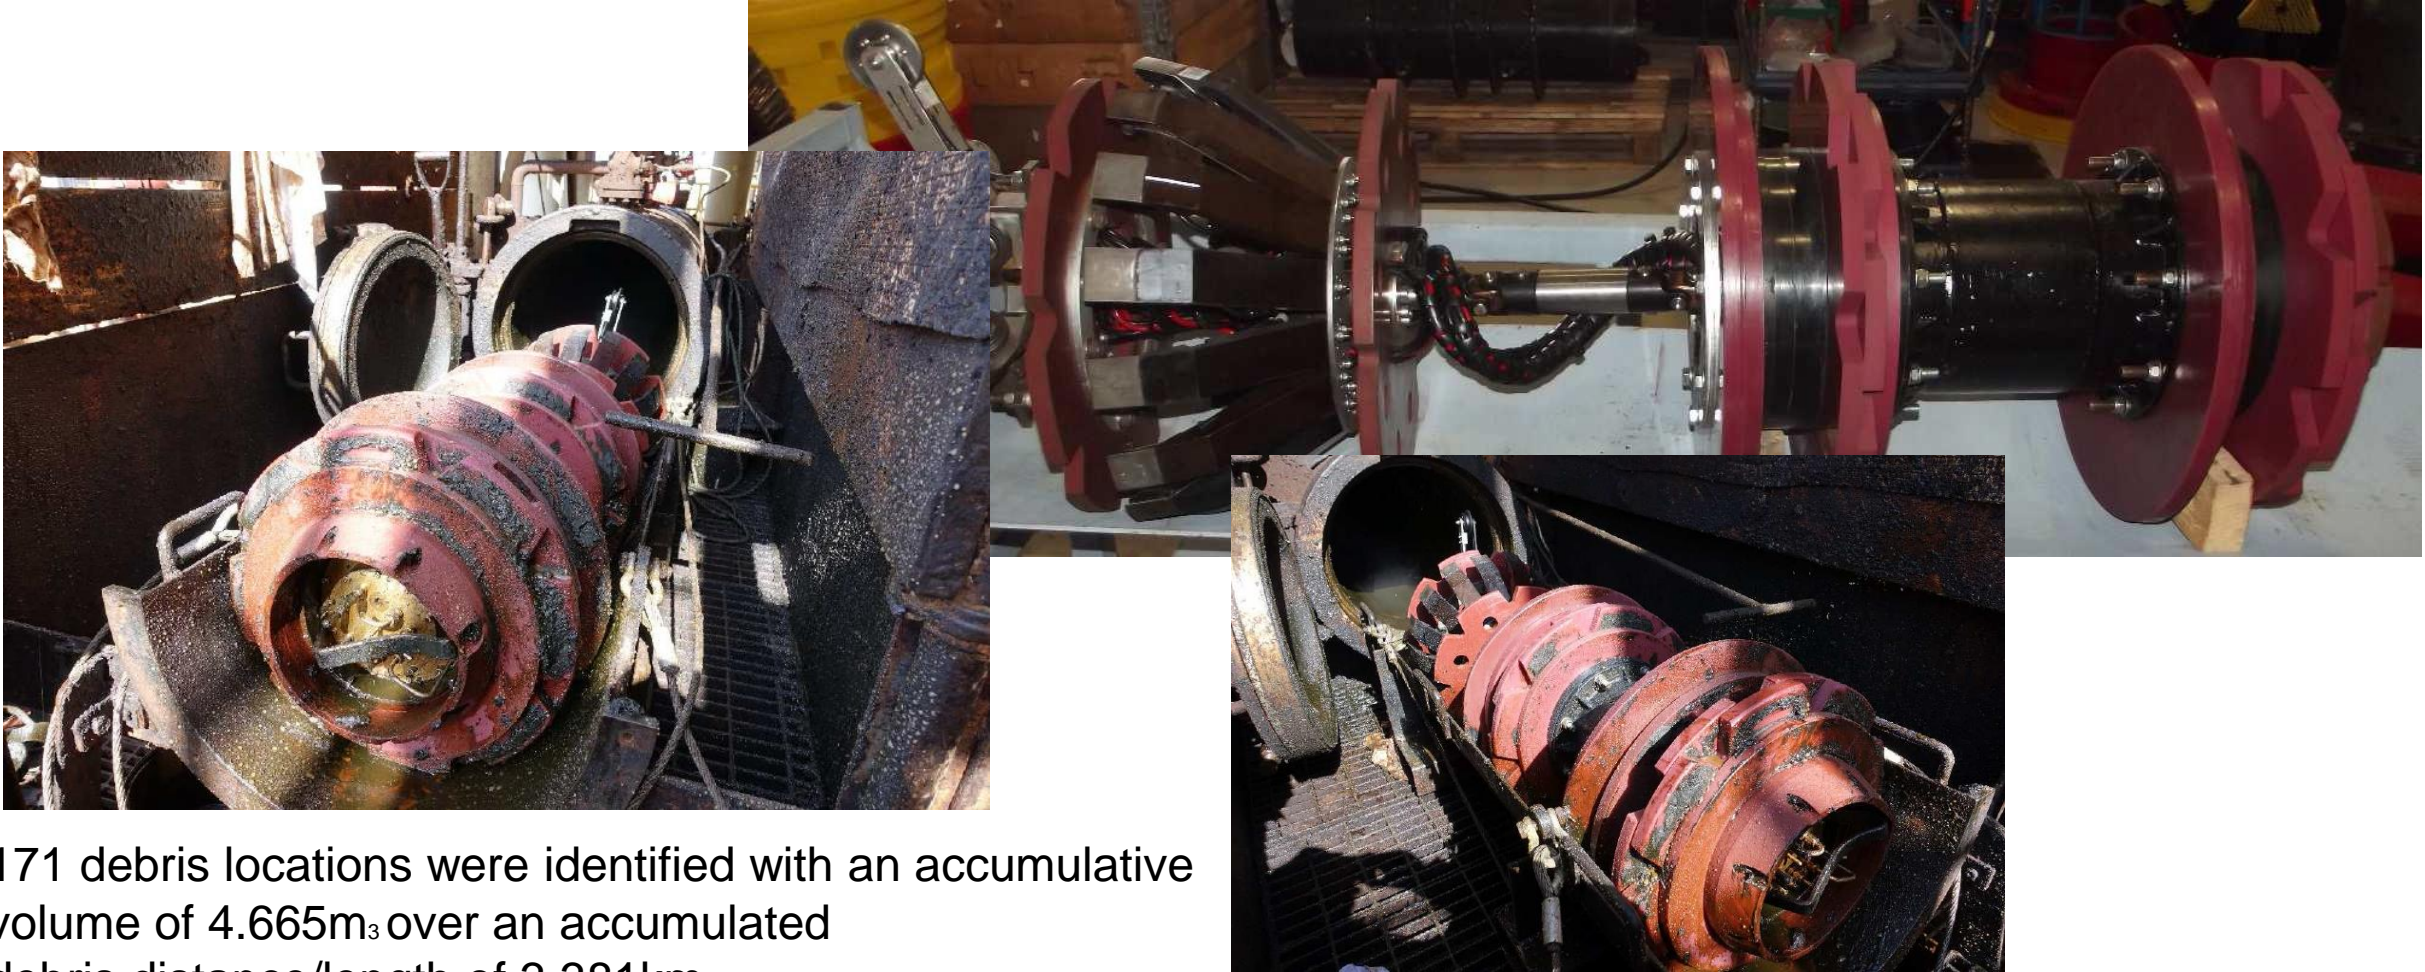
DEBRIS MAPPING TO TRACK CLEANING PROGRESS

171 debris locations were identified with an accumulative volume of 4.665m₃ over an accumulated debris distance/length of 3.381km.

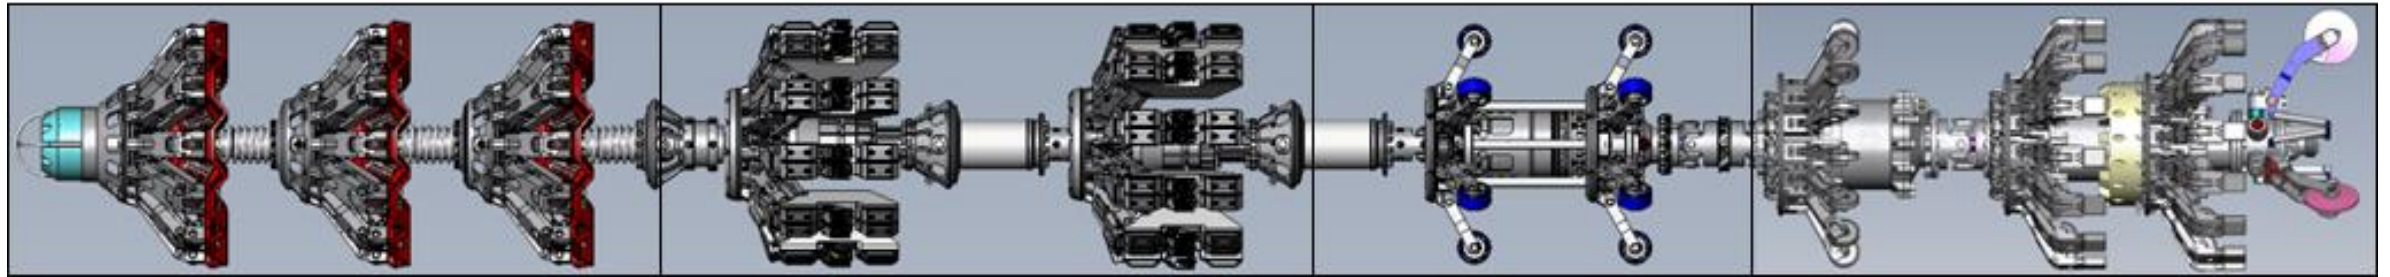
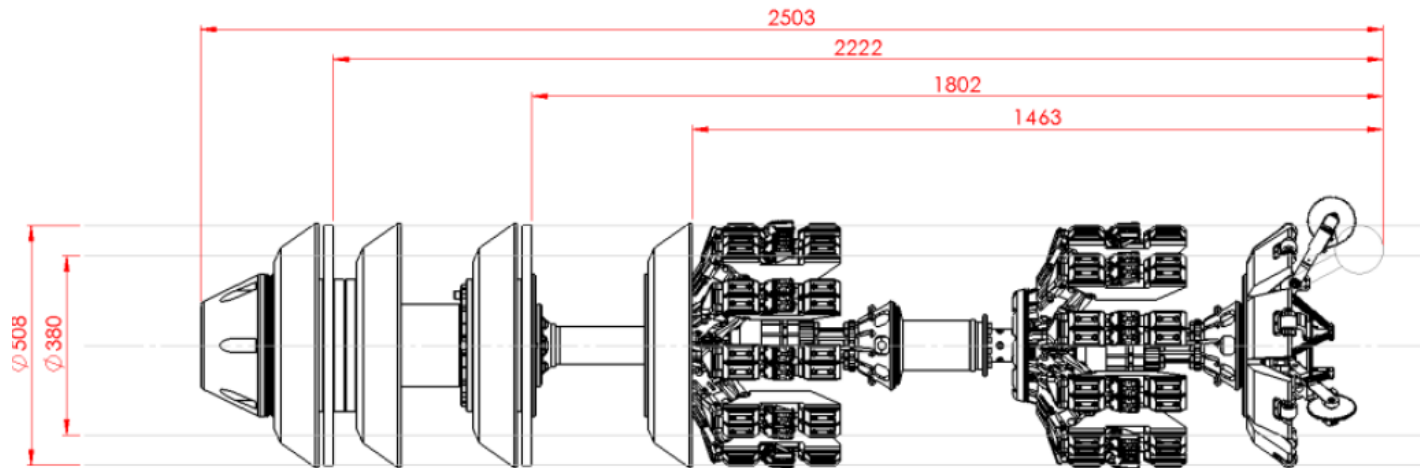
MFL ILI TOOL CONCEPT

Pull Unit

MFL-A Unit

Electronic Unit

Eddy Current/GEO/XYZ Unit

14-20" MuDi MFL – XGP
combo tool used as basis for
ultra compact 16-20" MFL tool

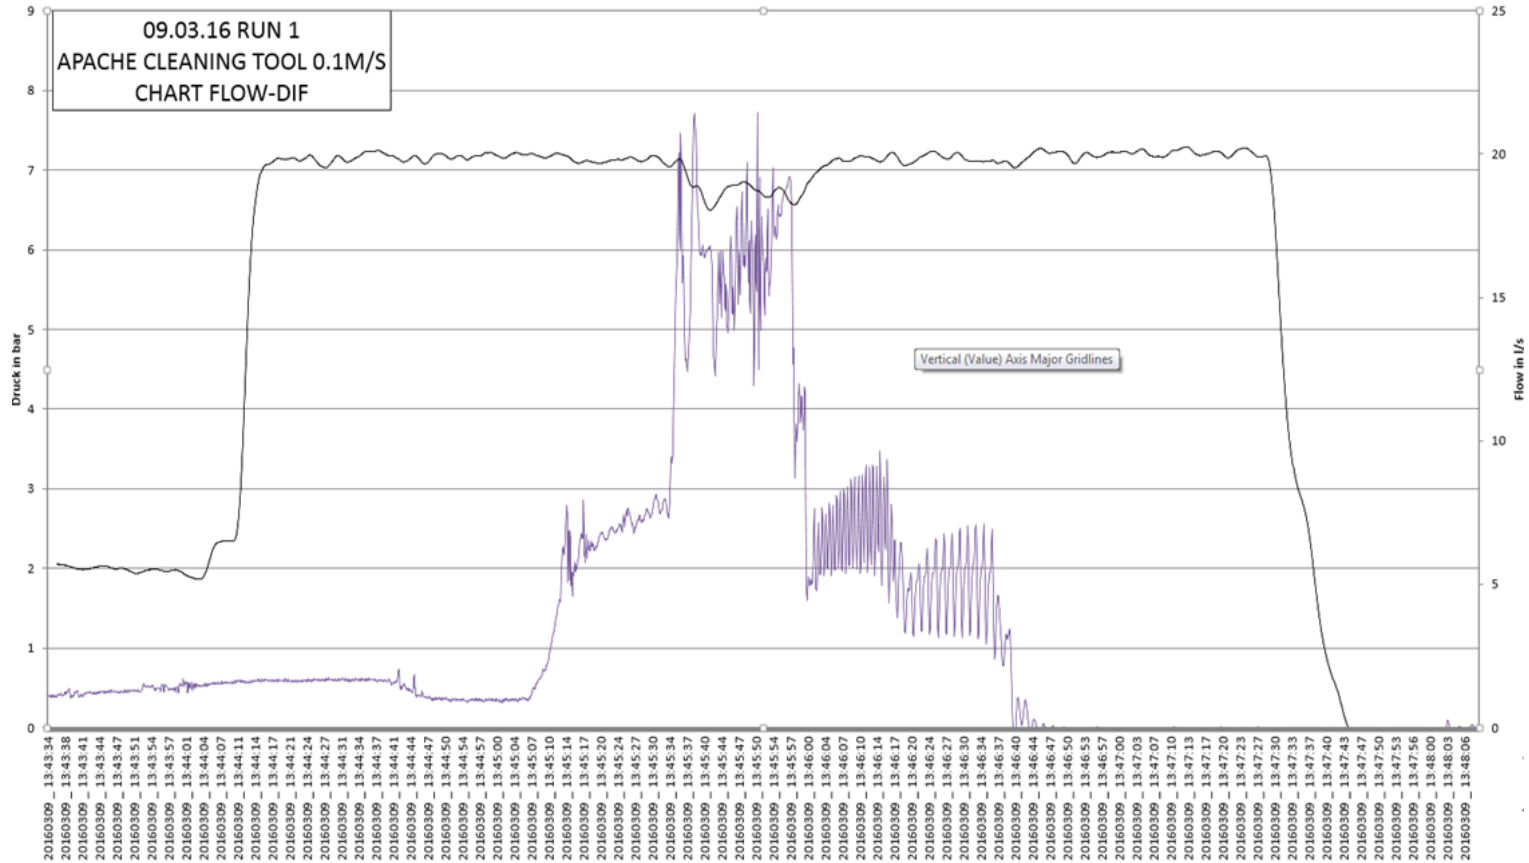
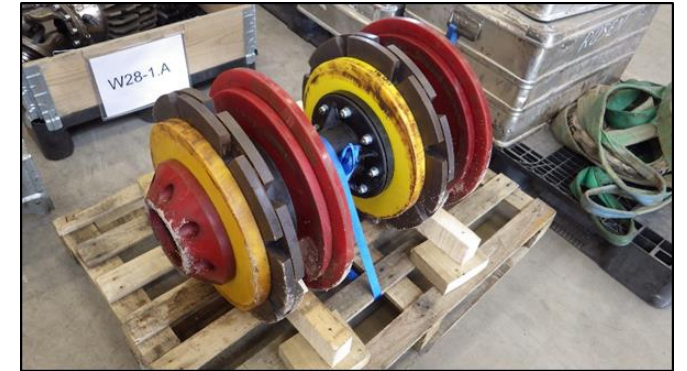
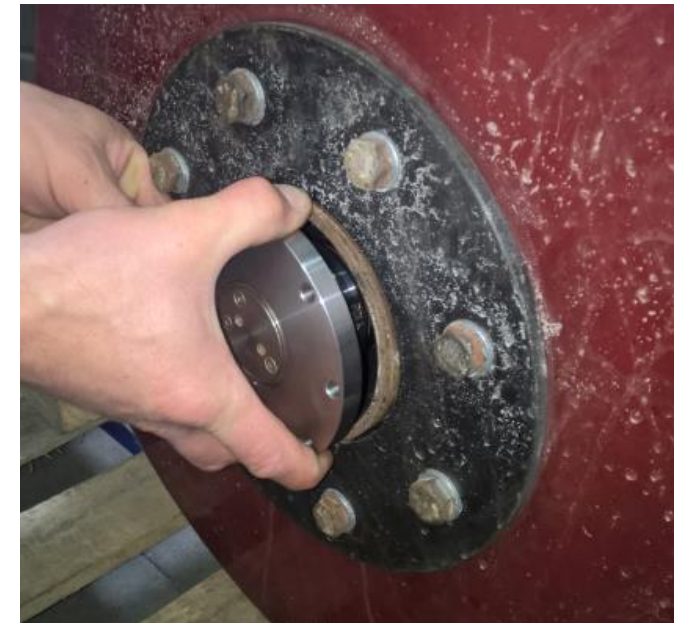
CLEANING TOOL WITH DATA LOGGER

Tool with Pipeline Data Logger used as bench mark for DP

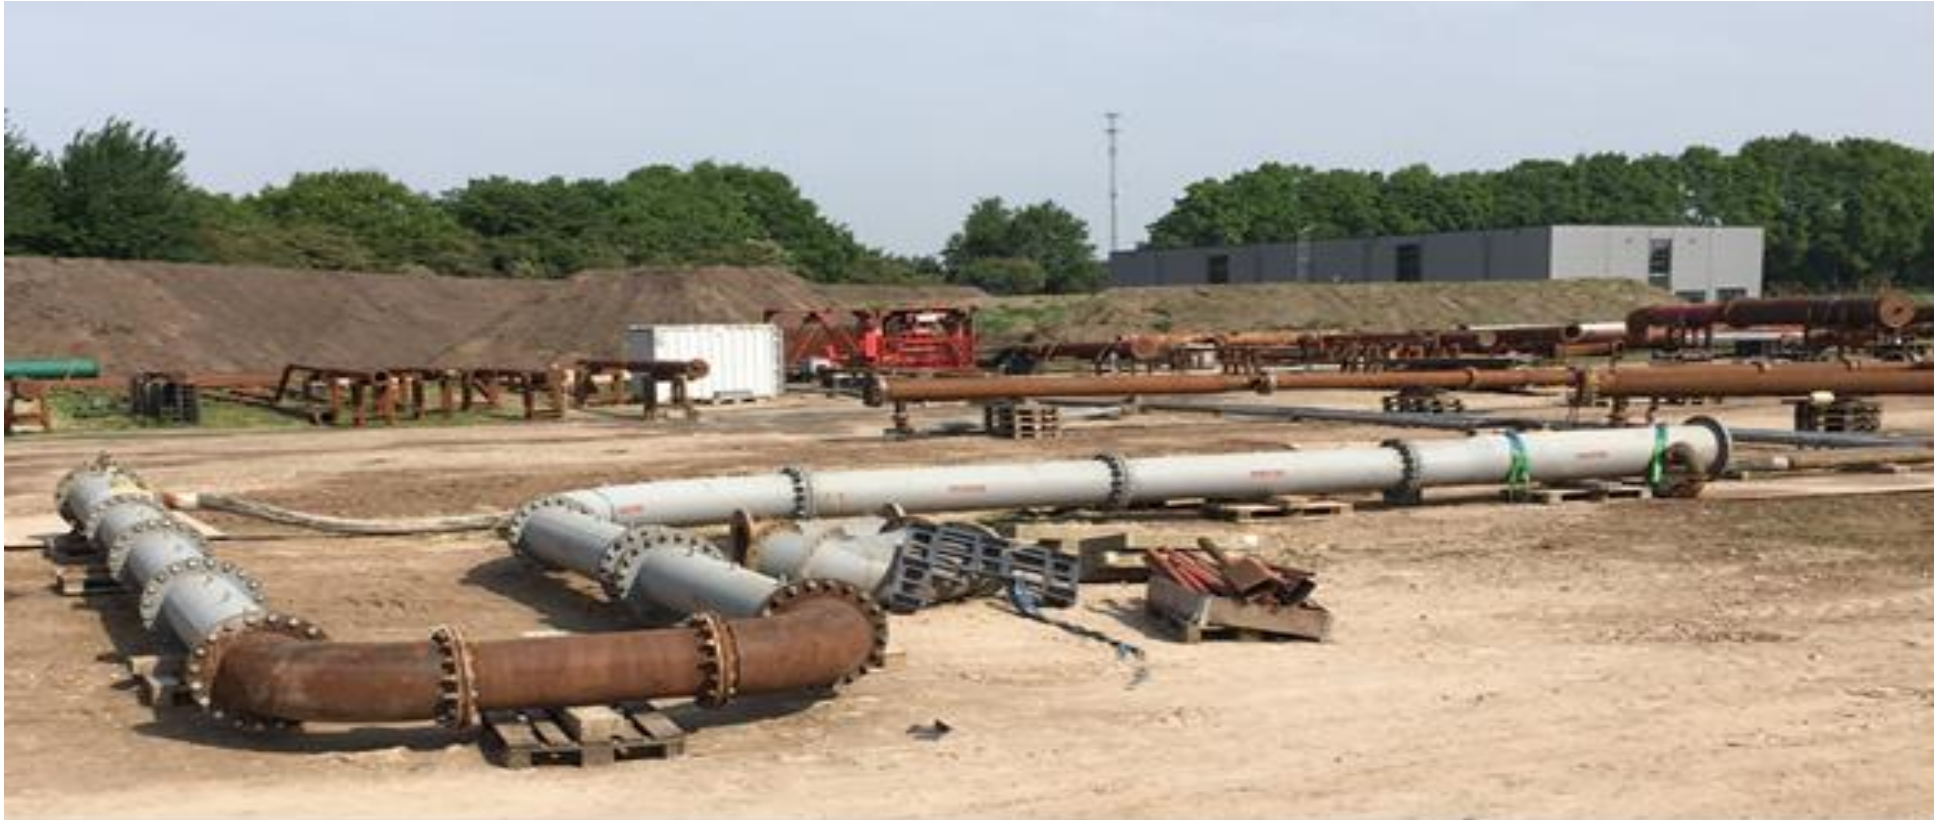
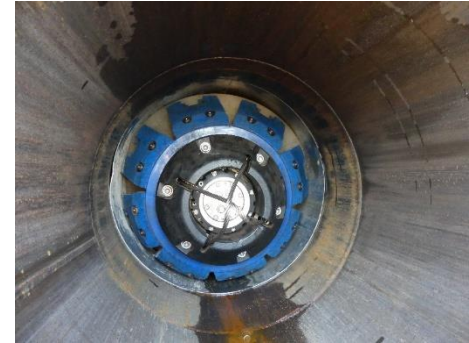
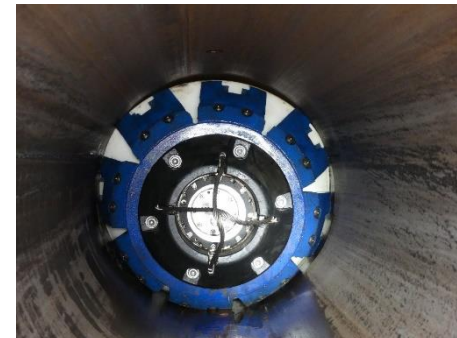
PUMP TESTING

Extensive testing performed (>70 pump tests) through iterative process to identify optimum set-up of seals as well as for the magnetizer.

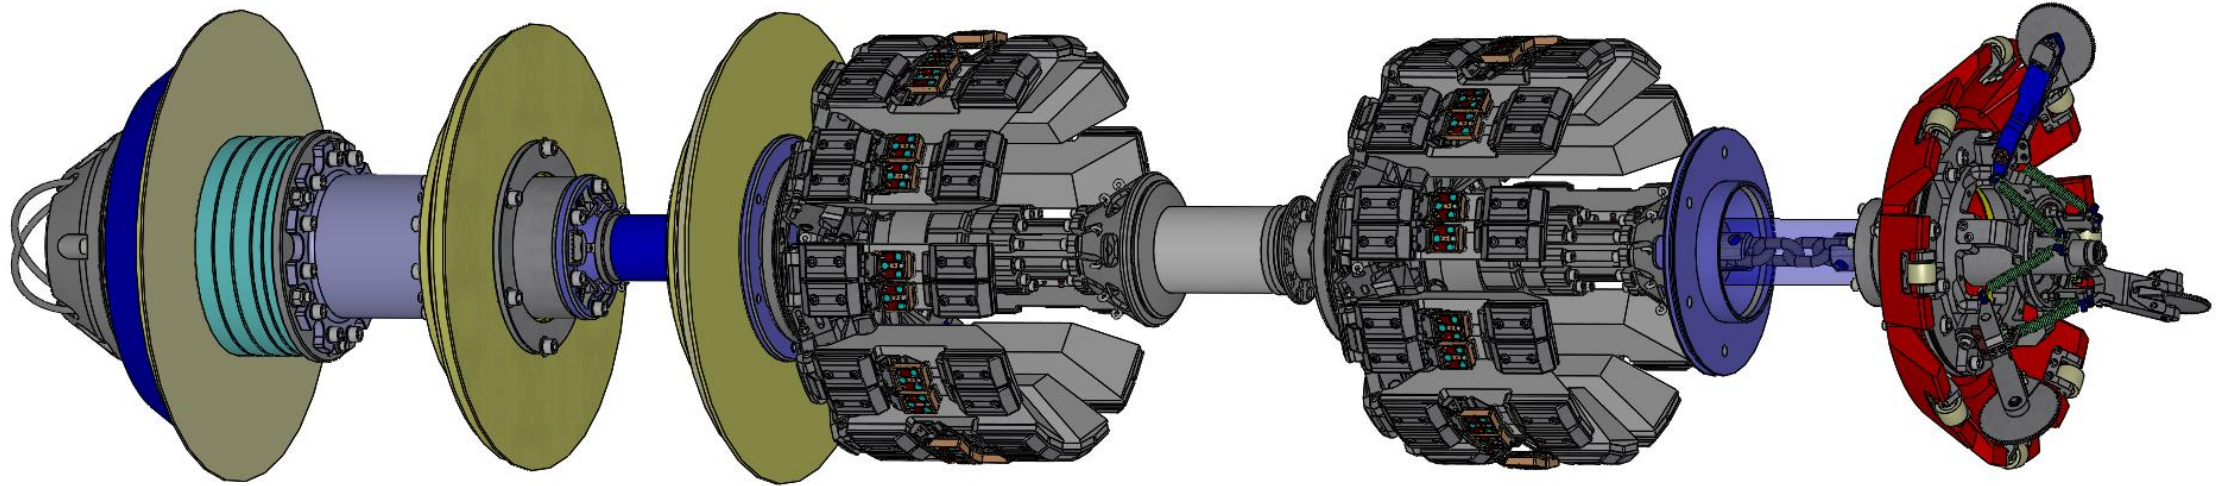
MFL ILI TOOL CONCEPT

Pull unit

- Type of sealing: cups, slotted guiding discs, sealing discs
- Position, diameter and thickness of the sealing elements
- Hardness

Magnetizer

- Split magnet units
- Magnet strength
- Yoke design

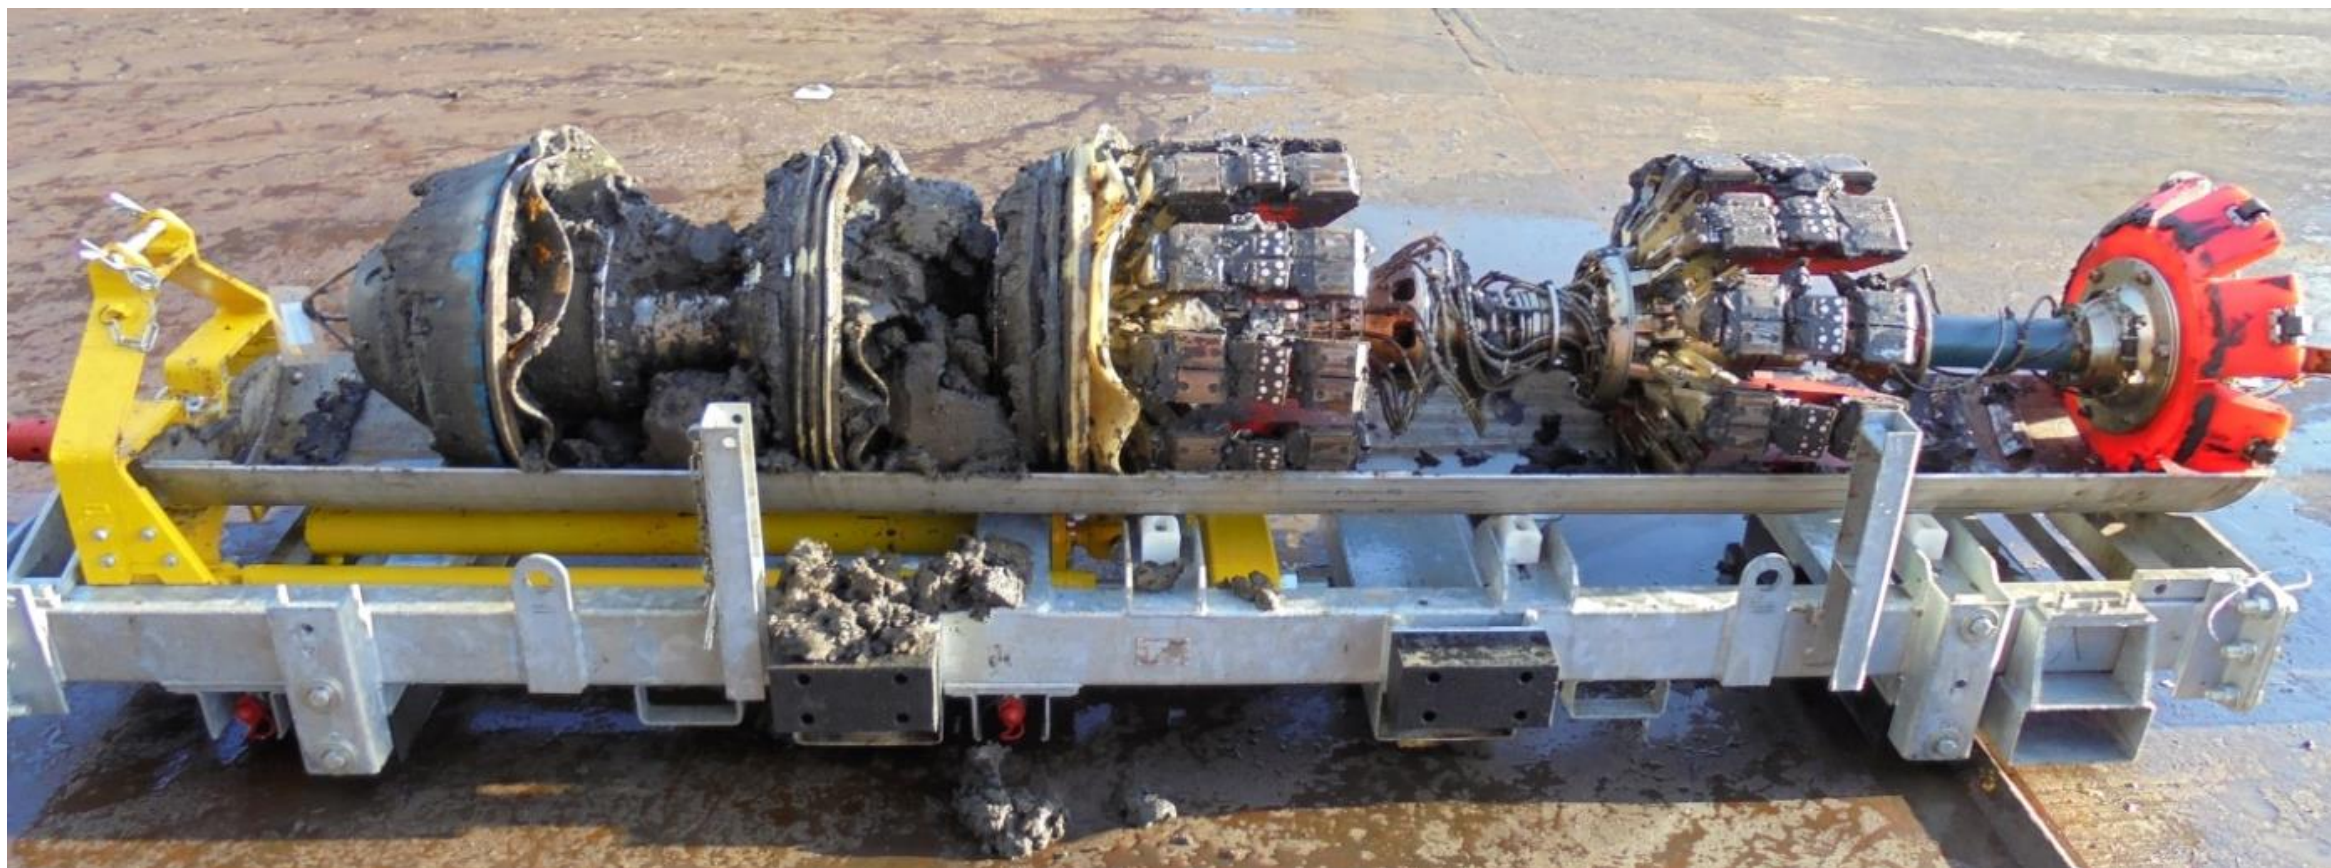
RESULTS

Launch date: 11th Feb 2018
Debris: Approx 50 kg of wax came off the tool

Traveling time: 11 hours 21 minutes
primary channel loss: 0.03%
