OPERATIONAL PIGGING PROGRAMS AND STUCK PIG RECOVERY FROM GAS EXPORT PIPELINE

By: Rolf Gunnar Lie T.D. Williamson, Regional Business Development Manager, Singapore
Stephanie Craig T.D. Williamson, Project Manager, Integrated Pigging Solutions, Norway

This white paper describes the key steps in the pig recovery operation, including planning, site visit, engineering, tool manufacturing and execution.

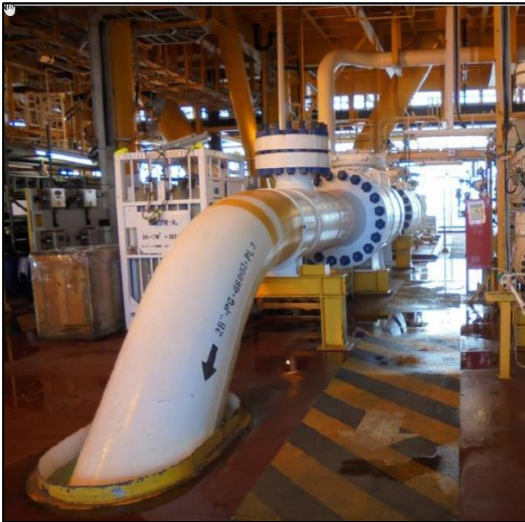
During operational pigging of the 28-inch gas export line in the PTTEPI gas field development in Southeast Asia, the 28-inch Bi-Di pig stalled and could not negotiate the barred production tee located immediately beyond the pig launcher isolation valves (See Figure 1). Because the pig was stuck halfway into the tee, it was not blocking the production flow entirely. However, the operator was concerned that, over time, the discs on the pig could lose force or a change in internal pressure could lead to the pig moving farther into the tee or line, blocking the flow completely. If the pig blocked the line, it could lead to shut down of production (See Figure 2) costing millions of dollars in lost production and serious impact on operations.

Figure 1: Gas Export Pipeline

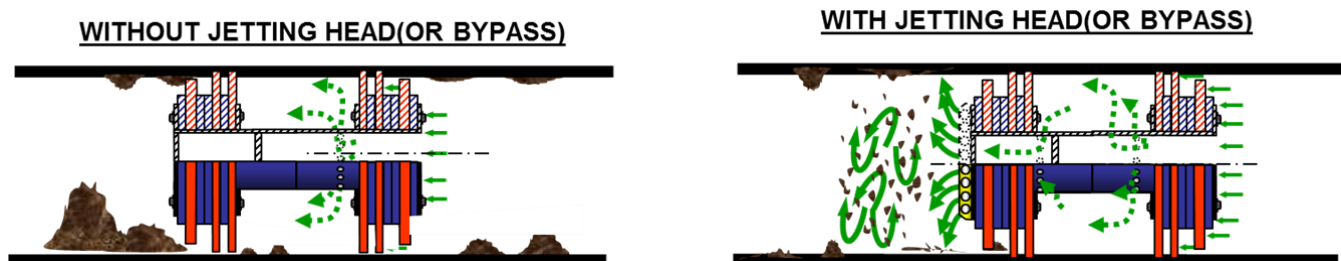
PTTEPI anticipated that the pipeline had a lot of debris that would collect in front of the pig during the pigging operation. When such debris is expected, it is normal to build some bypass into the pig to allow a portion of the gas flow to pass through it. As the flow passes ahead of the pig, it causes turbulence that will either flush debris ahead of it or allow the debris to be held in suspension in front of it. This avoids too much build-up in front of the pig that could eventually cause it to stall in the pipeline. (Figure 3)

Figure 3: Effect of bypass on debris

First, they used a Bi-Di pig designed with a large bypass that allowed a portion of the gas flow to pass through it, (Figure 3). Although some bypass is necessary, too much bypass means there won't be enough differential pressure to drive the pig.

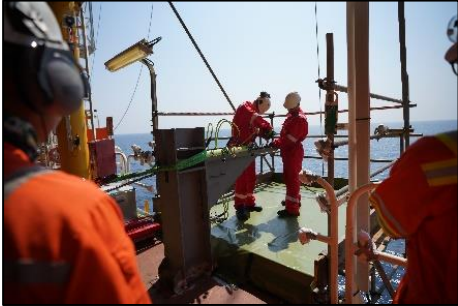
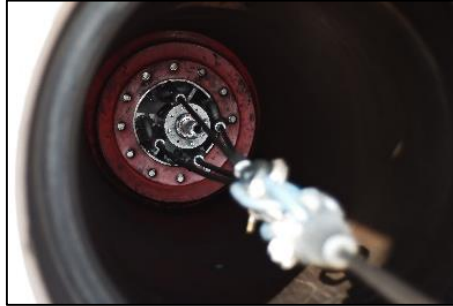
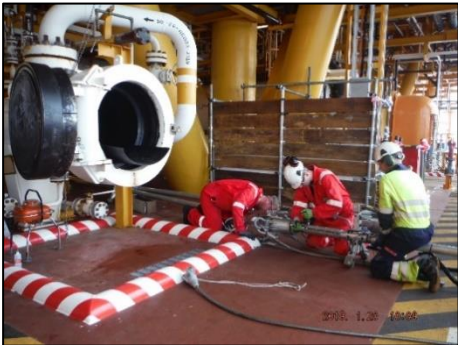
- Assembled the lance and gripping tool and inserted them into the pipeline.
- Locked the pig gripping tool in place in the bypass holes in the pig.
- Hooked up the pulling wire
- Started the pulling recovery operation
- Retrieved the pig from the launcher

Figure 12: Recovery operation offshore

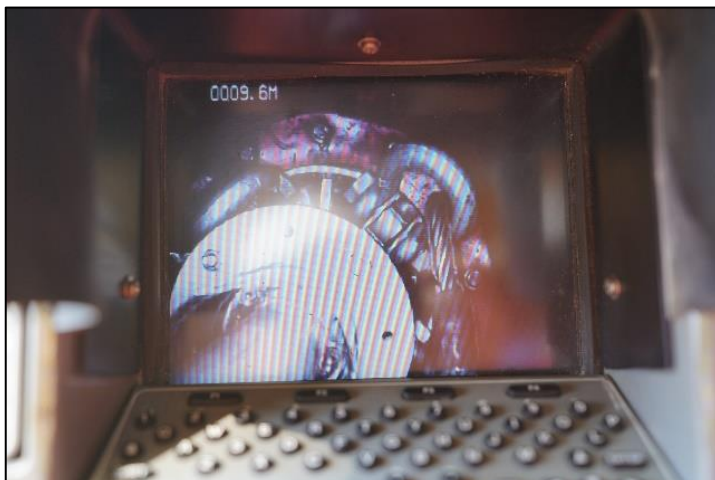
Figure 13: Camera monitor showing tool connected to the pig

- A gripping tool with spring-loaded pulling arms. (Figure 9) The arms were spring loaded to engage or “click in place” once they reached the bypass holes of the pig body.
- An installation with locking mechanism lance (shown in red in Figure 10) to install the gripping tool onto the pig body.
- Lance support wheel assemblies to centralize the lance in the pipe. (Figure 10)
- A pulling wire arrangement.
- A hydraulic pulling cylinder (furnished by TDW) with a “strong hold” anchor point operation (supplied by PTTEPI).
- A camera system to ensure the gripping tool engaged inside the launcher, where visibility was very poor (Figure 13).
