PPSA Seminar 2022

Navigating difficult underwater installation - an I/I challenge

PIPELINE INFORMATION

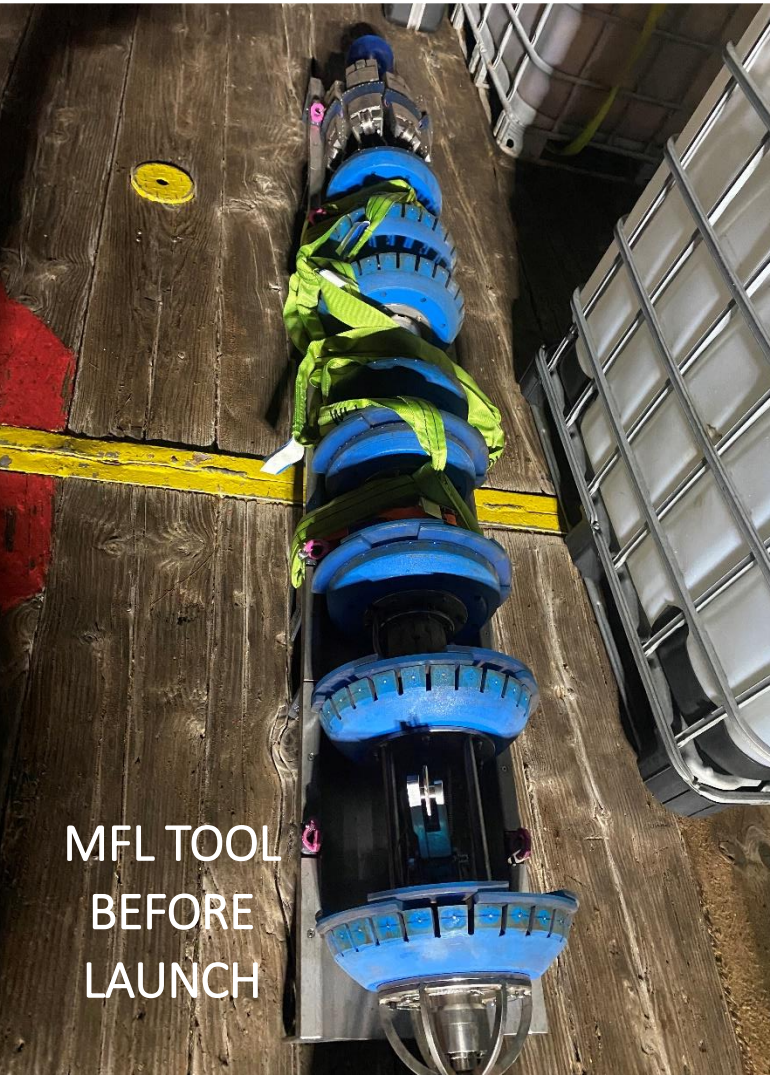
MFL TOOL
BEFORE
LAUNCH

TOOL LAUNCH IN 4M³ LIQUID
BATCH TO OVERCOME 1.5D BEND

TOOL RECEIVED IN GOOD
CONDITION AND COMPLETE
DATA SET – SUCCESSFUL ILI RUN
