## **EPRIS (Emergency Pipeline Repair Isolation System)**

Isolation Technology Developed to Facilitate Repair of Unpiggable Defects

Dale Millward Director – EPRS & Subsea Services

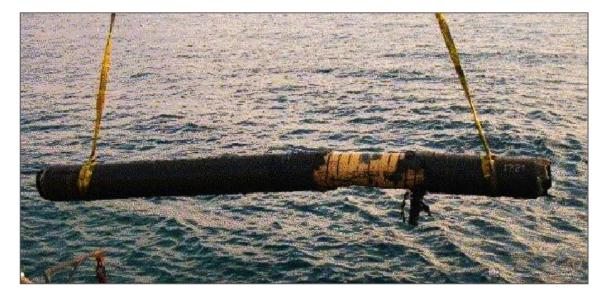
Following inspection and defect assessment, repair may require replacement of a section of pipeline.

Without double block isolation; need to flood and depressurise line to remove the damaged section and install a new section.

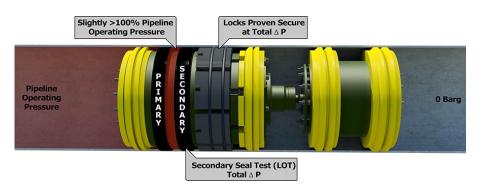
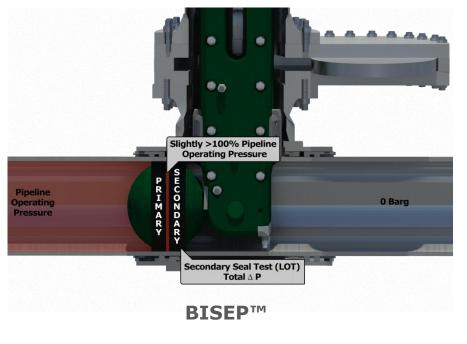
**Tecno Plug**<sup>™</sup>

### **Secondary Seal Integrity Test**

Pressure locked in the annulus Pressure behind vented,

Secondary seal tested with: Full differential pressure in correct direction

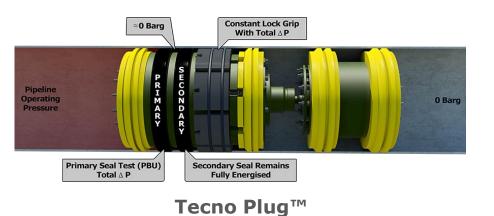
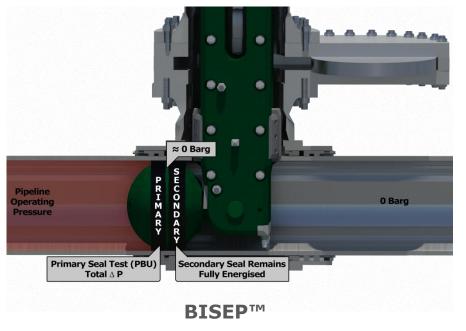
### **Primary Seal Integrity Test**

Pipeline pressure in front Annulus pressure vented

Primary seal tested with: Full differential pressure in correct direction

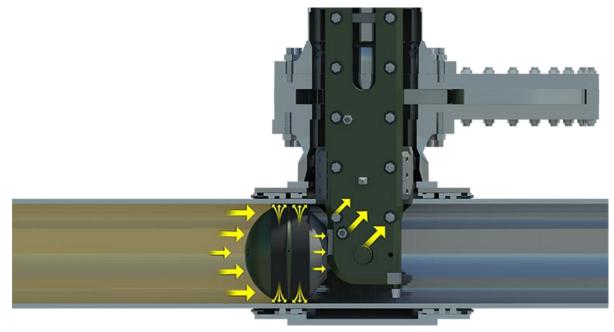
**BISEP™ Self-Energisation**

Fail-Safe Isolation Self-Energisation

- Pipeline differential pressure across BISEP<sup>TM</sup> activates seals independent of hydraulics
- Hydraulic set pressure ensure two independent activation mechanisms
- Seal support head bears on two solid clevis arms, each one capable of taking the full load (100% contingency)
- Clevis arms are axially retained by the hot tap penetration and fitting

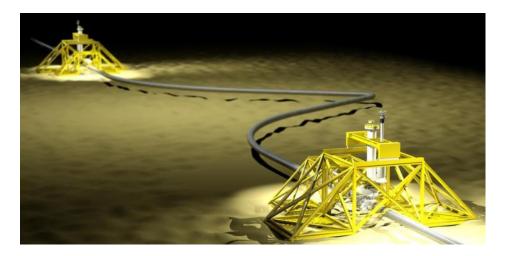
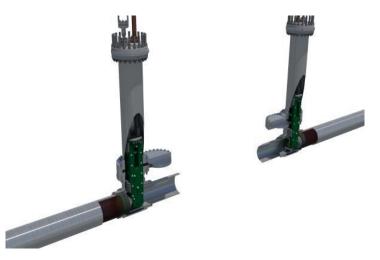
# BISEP midline Repair

With the isolation tools installed and tested.

Cut out damaged section

Install replacement section.

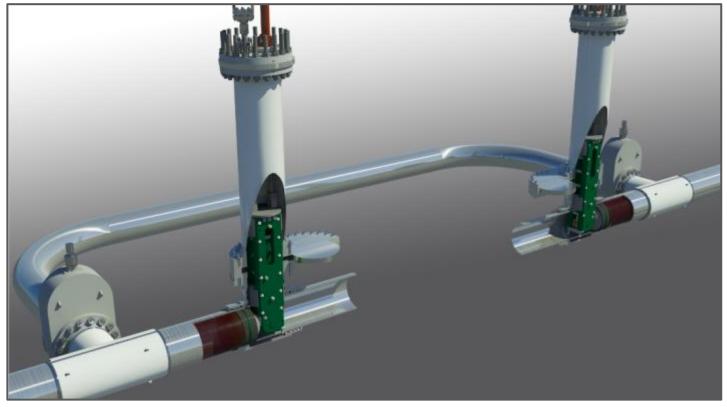
### **Midline Repair – Continuous Production**

Midline DBB Isolation With Bypass Repaired Without Stopping Production

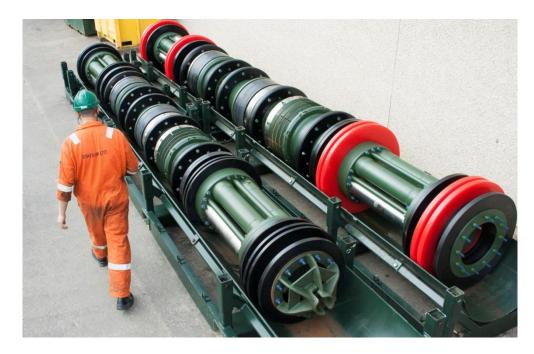
Tecno Plugs Developed to be pigged towards an unpiggable line defect – from both sides or to pass through a dent (less than 10%).

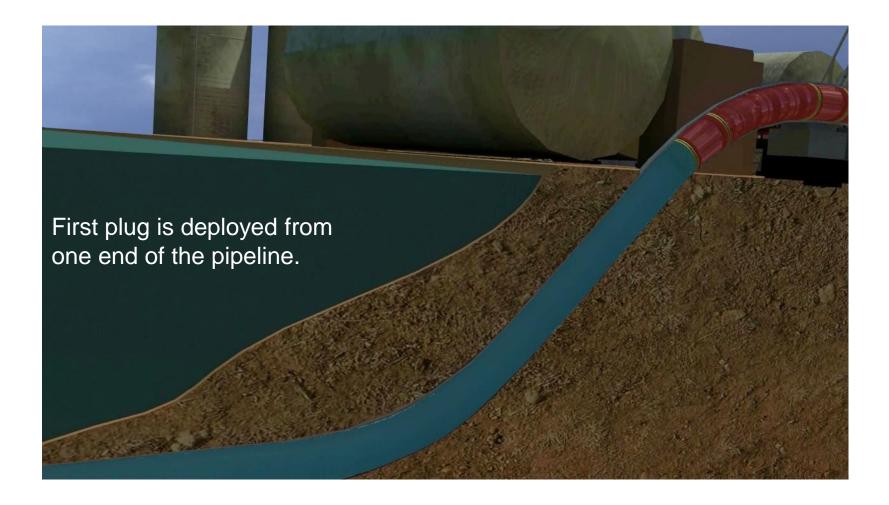
Isolation Plugs for 32" 34" 38" Pipelines (Two Plugs for each line)

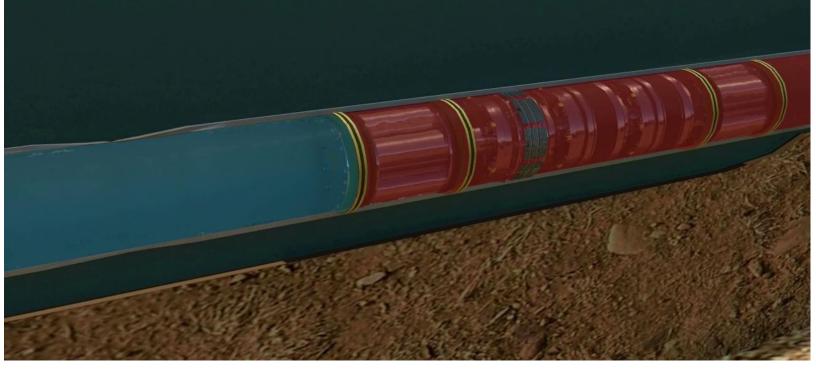
# Before reaching the line defect the plug is partially set (locks only)

## Through port vent opened.

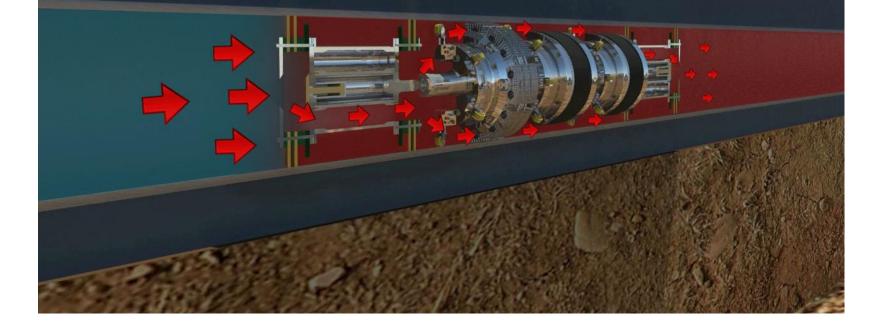
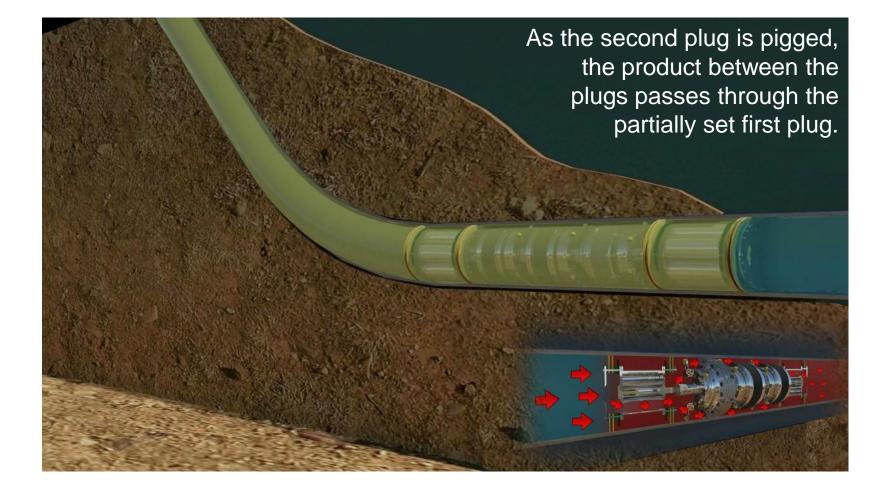
Opening the through port allows the second plug to be pigged from the other end of the pipeline - **towards** the first (partially set) plug.

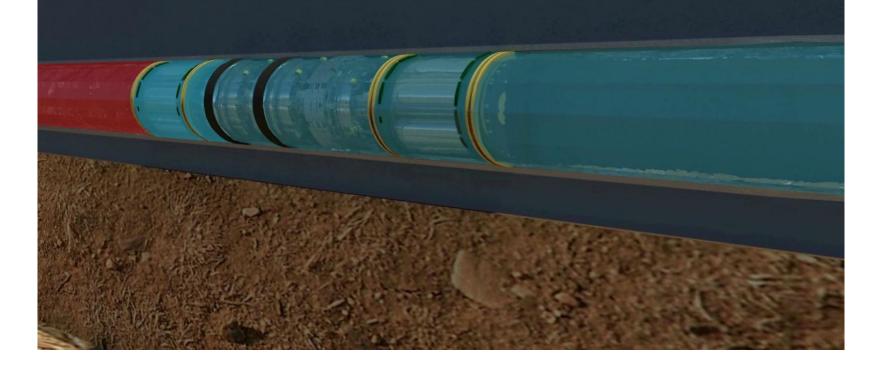
Once both plugs are at the desired set location the second plug can be fully set (locks and seals).

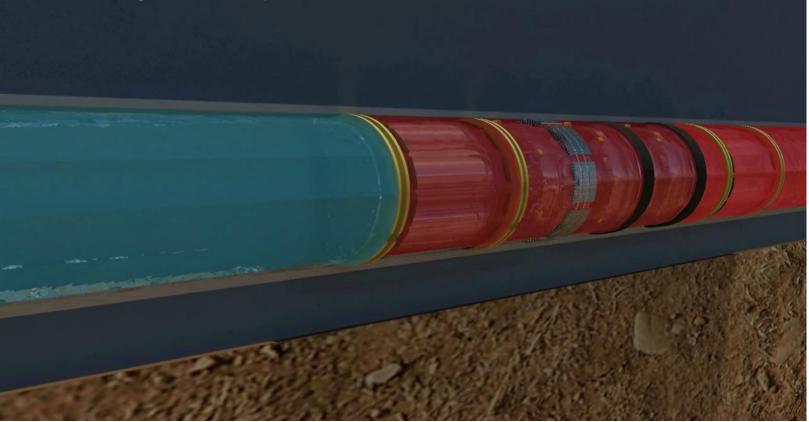
# The first plug is then fully set (seals compressed onto pipe wall)

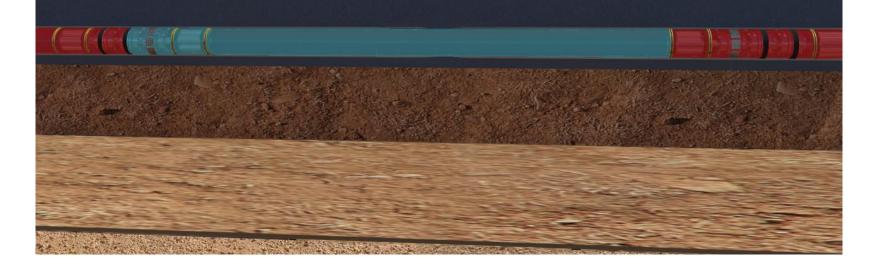
The damaged section of pipeline is now isolated.

Double Block Isolation of both plugs is proved.

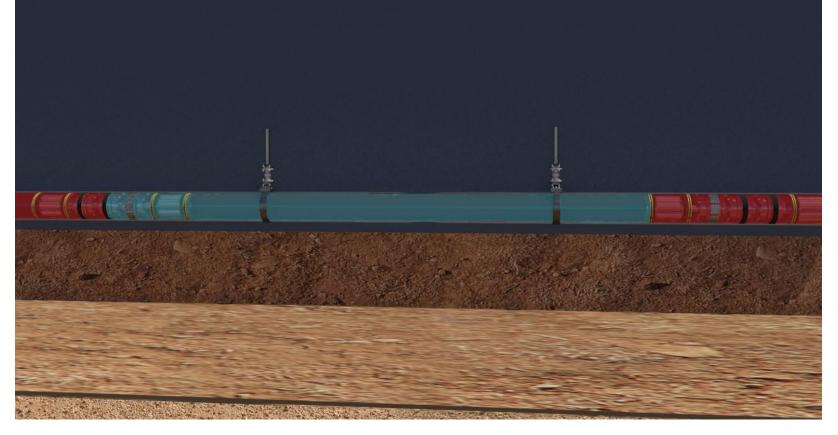
# Lightweight Hot-tap Clamps used to flush and vent between the plugs.

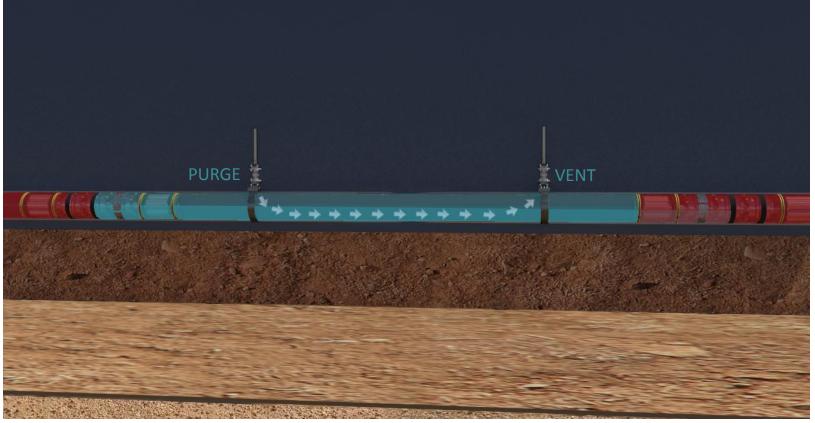
# The isolated area is flushed to remove hydrocarbons

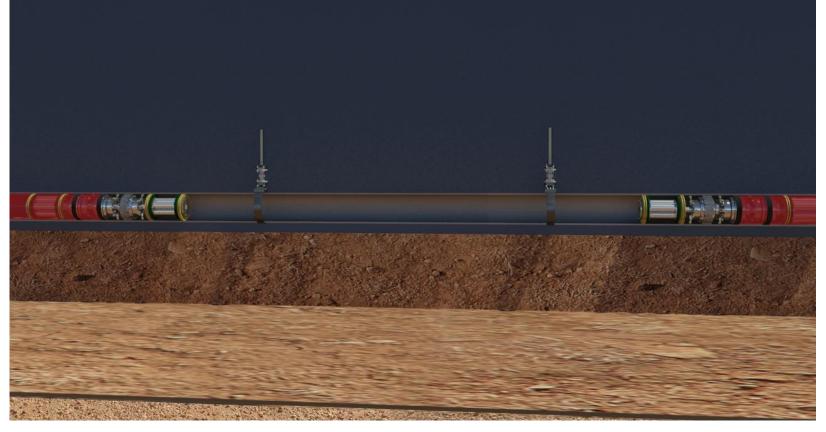
# The Isolated section is then fully vented to (subsea) ambient.

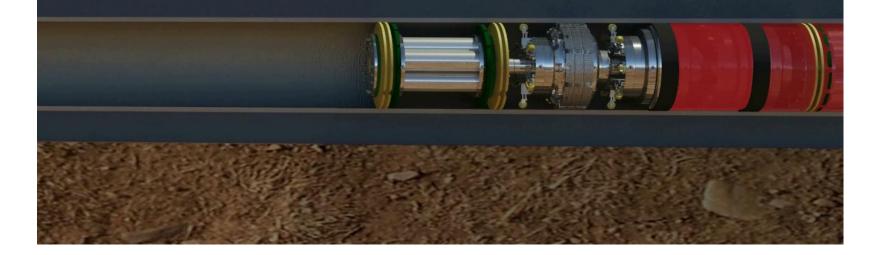
### Pressure between the seals is monitored to prove the Secondary seal.

### Secondary seal tested with full pressure in the correct direction.

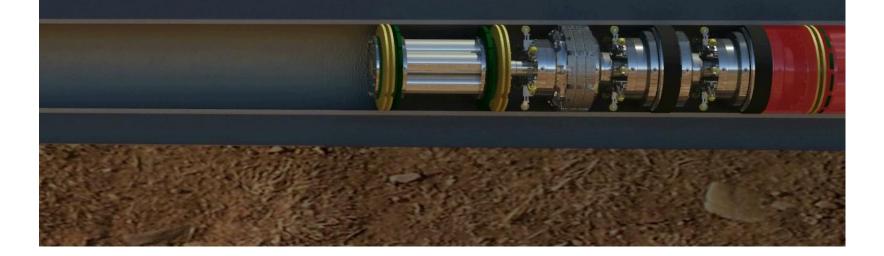
Annulus between the seals is vented to produce a zero energy zone.

Pressure build up test of annulus proves primary seal isolation.

Primary seal is tested with full pressure in correct direction.

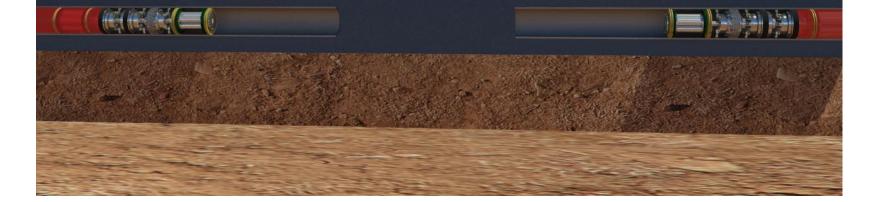
Pipeline repair work is carried out.

Line is not flooded

Inventory is not lost.

Environment is not contaminated

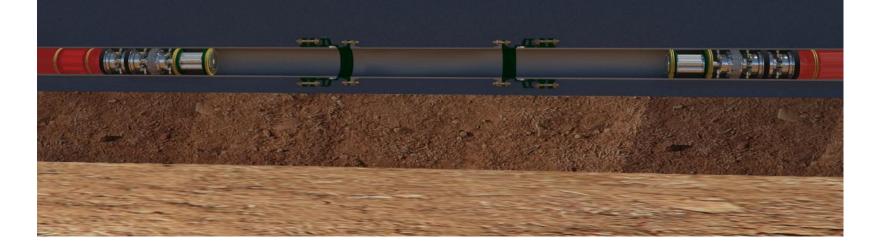
# New section of pipe installed

# Using mechanical connectors or hyperbaric weld.

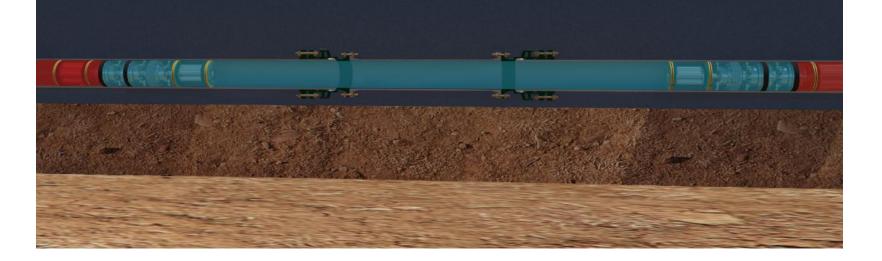
# Leak test the repair

# Equalise pressure and unset both plugs

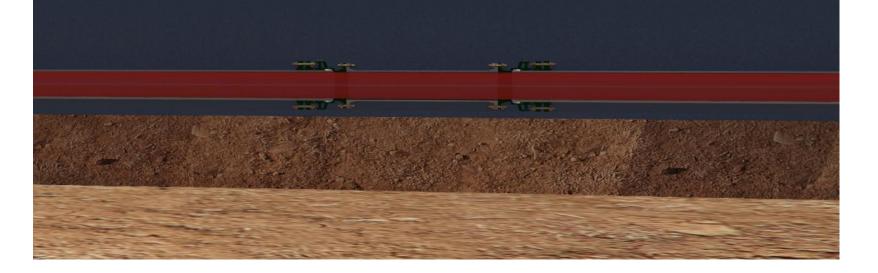
## Pig both plugs back to one end of the pipeline using production flow.

### Remove from receiver
